Bulletin 1334 & 1335

Modulator Logic Board 50387-002

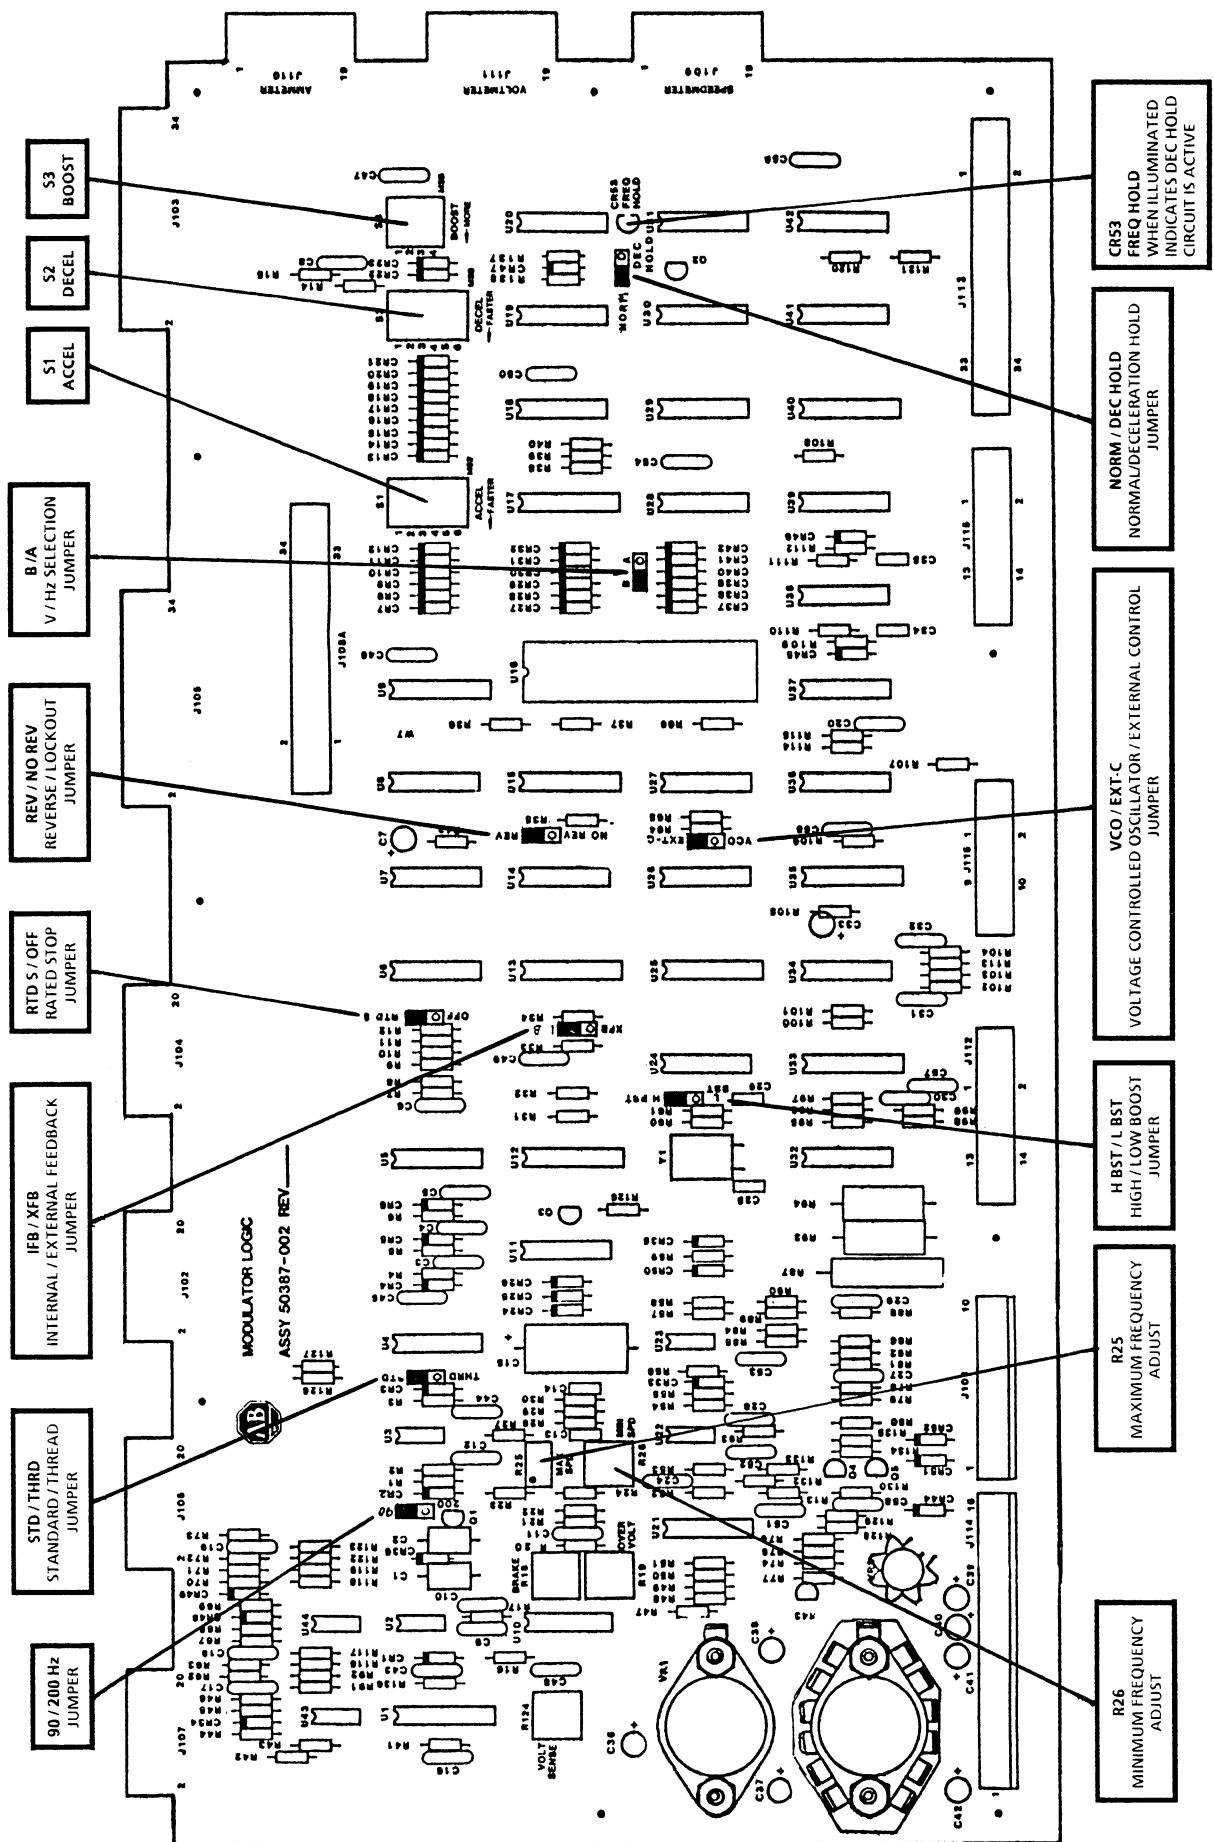
CR53 FREQ HOLD WHEN ILLUMINATED INDICATES DEC HOLD CIRCUIT IS ACTIVE

NORM / DEC HOLD NORMAL/DECELERATION HOLD JUMPER

As shown on the facing page, the V/Hz jumper setting on the new board has been relabeled B and A.
