Bulletin 1336 MOD-E1 Handheld Terminal

Firmware Update Kit SP-148340

Installation Data

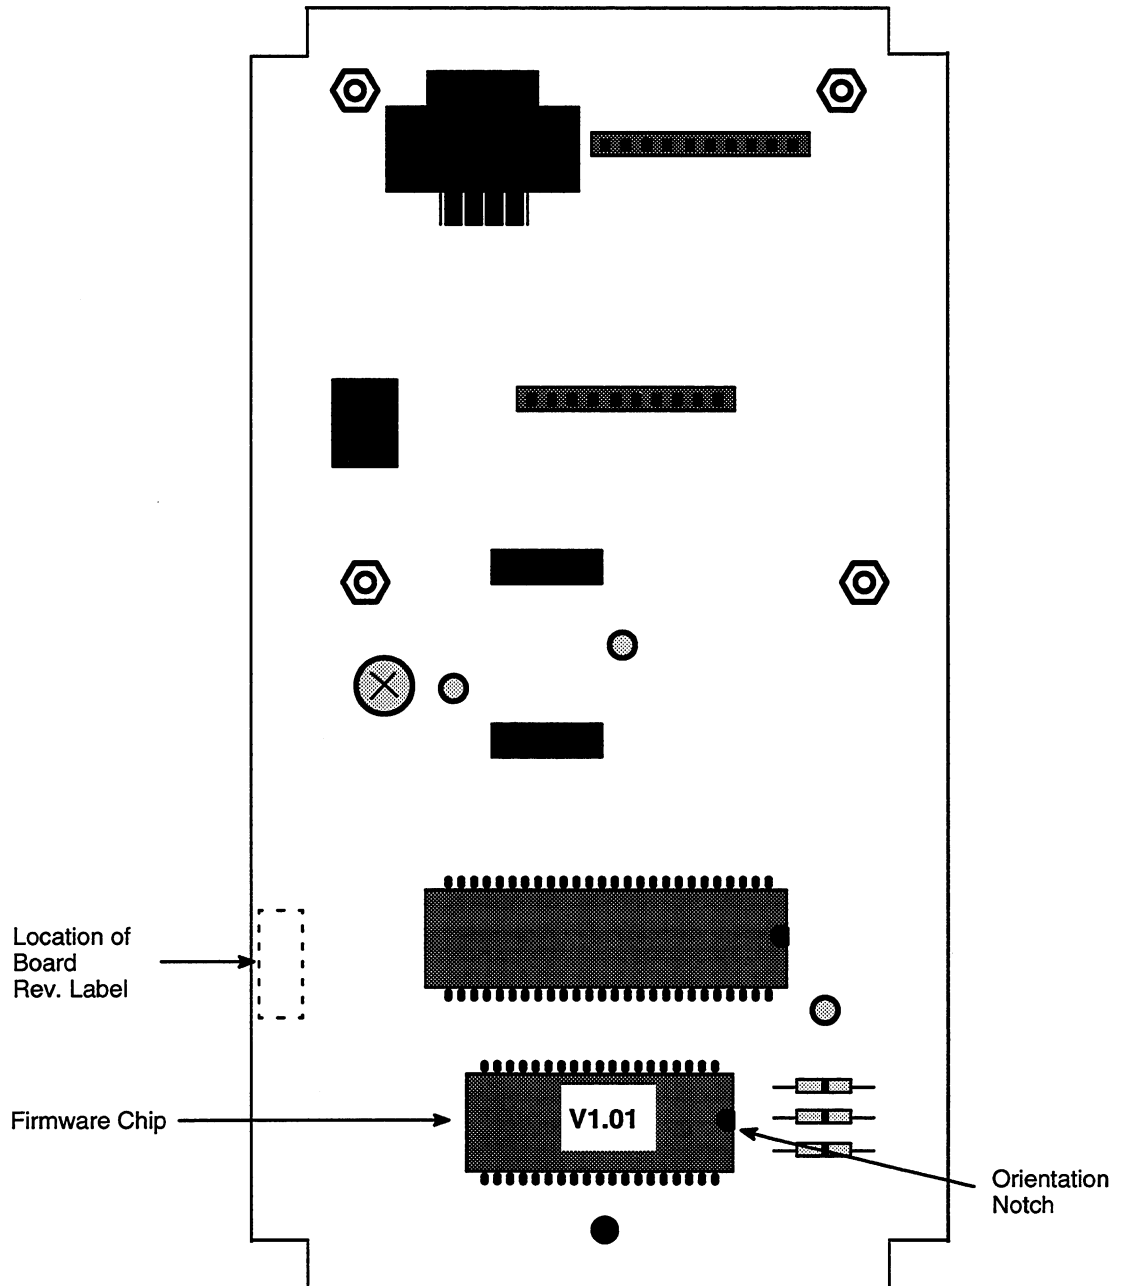
Figure 1. Bulletin 1336 HHT Firmware Chip Location

The Bulletin 1336 MOD-E1 Handheld Terminal (HHT) has been updated to provide several firmware enhancements. This V2.01 update to the handheld terminal allows the terminal to be compatible with the Version 2.01 firmware in the Bulletin 1336 Drive. The purpose of this publication is to describe the steps required to properly replace the old firmware chip Version 1.01 with a Version 2.01 chip. A box, label and anti-static bag are included for returning the old chip.

2. Put on the ESD wrist strap and attach the end of the wire to a bare grounded surface.
3. Remove the four (4) phillips screws holding the back on the HHT enclosure and remove the back to expose the main board (Fig. 1).

4. Refer to Figure 1 and remove the firmware chip using the chip puller. Note the chip orientation notch when inserting the new Version 2.01 chip on the board. Use extreme care not to bend the chip leads when inserting the new chip.
5. Paste the white revision label in the indicated position on the board and fill in the date.
