## 1394 Firmware Upgrade Monitoring Instructions (Catalog Numbers 1394-SJT05, -SJT10, and -SJT22)

This document describes how to monitor the current CPU values for the 1394 GMC system modules (Catalog Numbers 1394-SJT05, -SJT10, and -SJT22).

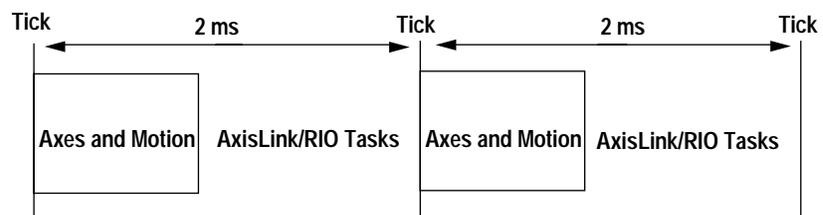
**Figure 1**  
**Time Sequence**

For example, if the Servo Update Rate parameter is set to 500 Hz (factory default), the time between ticks on the clock is 2 ms. As CPU utilization exceeds 70-80% and the Servo Update Rate parameter is set to 500, program execution may stop and RIO communication might fail.
