ControlLogix™ Redundancy System

Cat. No. 1756-CNB/D, -CNBR/D, -L55, -L55M12, -L55M13, -L55M14, -L55M16, -L55M22, -L55M23, -L55M24, 1757-SRM/A, -SRM/B

Publication 1756-RN582N-EN-E - June 2003

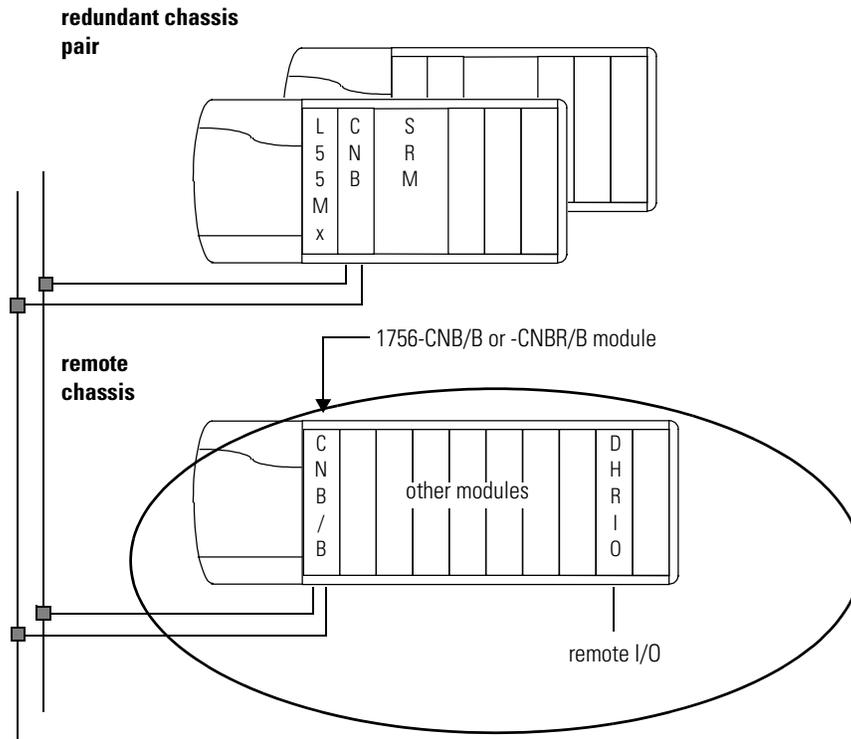
Restriction:	Description:
Communication Loss When Bridging Through a 1756-CNB/B or -CNBR/B Module	<p>The following combination of modules in a remote chassis could cause a temporary communication loss with the chassis:</p> <ul style="list-style-type: none"> • 1756-CNB/B or -CNBR/B module • 1756-DHRIO module that is connected to a remote I/O network.

On the first switchover after you download a project to the controller, you may temporarily lose communications with these devices.

The loss of communication occurs on the first switchover after you download the project to the redundant controller.

- You lose communication with the remote chassis and any devices to which you were bridging via the chassis, such as the remote I/O modules.
- During the communication loss, the I/O modules go to their configured state for a communication fault.
- The communication loss is temporary. Communications restore themselves.

To prevent this situation, use 1756-CNB/D or -CNBR/D modules.
