## ControlLogix® Controller Revision 12

Cat. No. 1756-L1, -L1M1, -L1M2, -L1M3, -L55, -L55M12, -L55M13, -L55M14, -L55M16, -L55M22, -L55M23, -L55M24, -L61, -L62, -L63

Publication 1756-RN601D-EN-E - June 2004

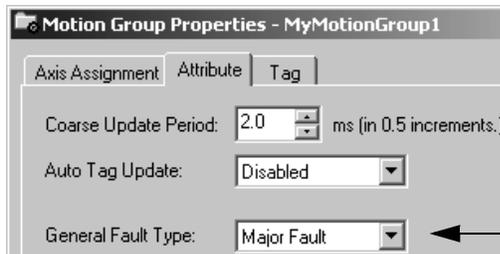
Change:	Description:
While in Program Mode, a Motion Group Fault No Longer Produces a Major Fault	As an option, you can configure a motion group to produce a <i>major fault</i> any time the group detects a motion fault.

With this revision, a motion group that is configured to produce a major fault produces a major fault *only* if the controller is in run/remote run mode.

In previous revision, the motion group could produce a major fault while the controller was in program/remote program mode. For example, a store to nonvolatile memory interrupts the execution of the motion planner, which produces a fault.

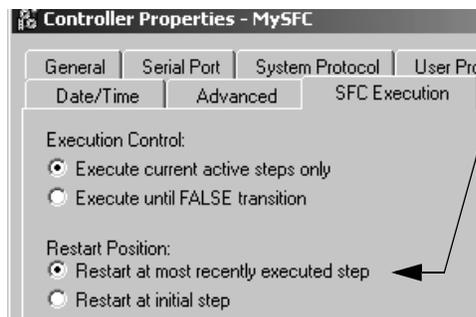
Improvements in How an SFC Restarts After Its Execution Is Aborted	<p>This revision provides better handling of situations where the execution of a sequential function chart (SFC) was aborted due:</p> <ul style="list-style-type: none"> <li>• loss of power</li> <li>• controller entered the faulted mode (flashing red OK LED)</li> </ul> <p>The changes include the following:</p>
--	--

Regardless of this setting, the SFC *always restarts at the initial step* after a change from faulted mode (flashing red OK LED) to run/remote run mode.
