ControlLogix Combination Controller and SERCOS Interface Card, Firmware Revision 17

Catalog Number 1756-L60M03SE

Publication 1756-RN655C-EN-E - February 2010

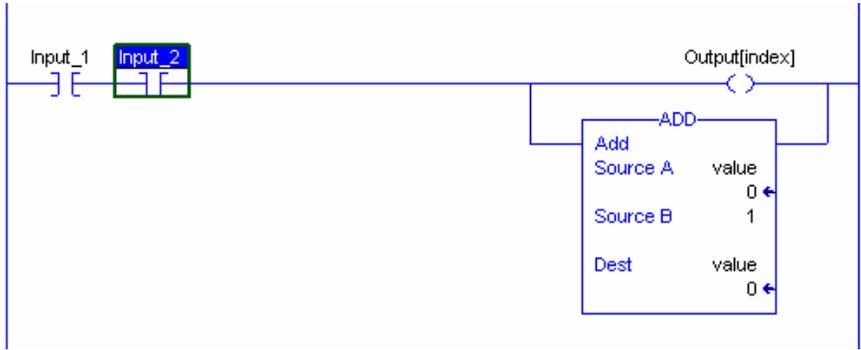
Firmware Revision	Description
17.04	<p>Fault handlers can be defined at the controller and program scope levels. These fault handlers are typically used to handle major recoverable faults that can occur during runtime execution of an application due to programming errors. A typical example of this would be handling indirect addressing that has gone out of range; <code>MyTag[index]</code>, where <code>index</code> is larger than the size of the array.</p> <p>Faults can also be handled by the controller during pre-scan of the controller program on the transition to Run mode. Again, for example, the handling of indirect addressing that has gone out of range.</p> <p>There is an anomaly when these methods attempt to handle a fault.</p> <p>These are the possible ways the anomaly can manifest itself:</p> <ul style="list-style-type: none"> • The controller will experience a major nonrecoverable fault. I/O goes to their configured safe state, and the user application is cleared from memory. At this point, a Code 1 Type 60 or 61 major recoverable fault will be logged in the controller. This requires you to redownload the application. • Tag data corruption. • Online saving or uploading failures. • Anomalous program execution. <p>For example, if a rung is being scanned false and there is an instruction that has false execution, the fault handler executes so the remainder of the rung will scan true. In the example below, the OTE instruction has an index out of range. After returning from the fault handler, the ADD instruction will execute, even though the rung input conditions are false.</p>

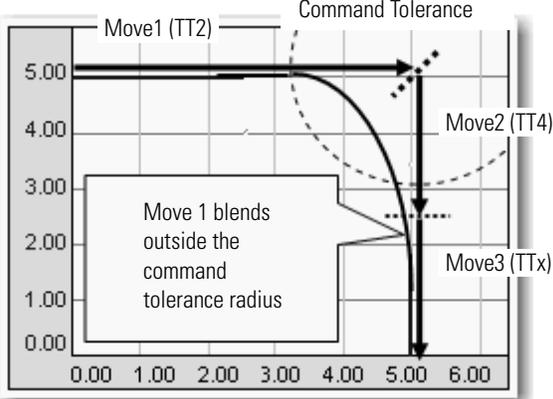
Firmware Revision	Anomaly	Description
17.02	Combination of Termination Types may cause you to miss the target position	<p>You may have missed hitting the end point of a move with Termination Type 4 or 5 (TT4/5) when it was preceded by another move with Termination Type 2 or 3 (TT2/3). See figure below as one possible combination:</p>
