# ControlLogix DeviceNet Interface Module

Catalog Numbers 1756-DNB, Series C and D

These release notes correspond to the 1756-DNB DeviceNet interface module, series C and D, firmware revision 11.005 and earlier.

Publication 1756-RN660C-EN-P - February 2011

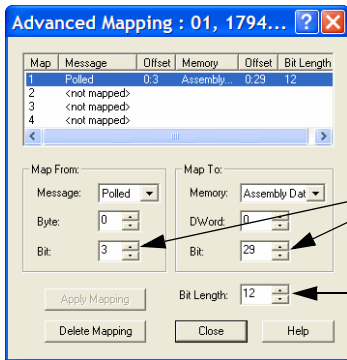
Corrected Anomaly	Description
Data value of -273817920 (0xEFADDEC0) appeared in controller input tag	<p><b>CORRECTED:</b> When the connection from the Logix controller to the 1756-DNB series C module was reestablished, the data in the input tag for the 1756-DNB module was invalid until the first input packet was received from any node on the DeviceNet network in the 1756-DNB scan list. If the connection was reestablished after the 1756-DNB module was power cycled, a data value of -273817920 (0xEFADDEC0) appeared in the input tag until the first input packet was received.</p> <p style="text-align: right;">Lgx00082315</p>
Module faulted when using Advanced Mapping	<p><b>CORRECTED:</b> The 1756-DNB module faulted when using Advanced Mapping for the Input Table or Output Table, with bit offsets or data sizes that are not multiples of 8 bits.</p> <div style="text-align: center;">
