1769 CompactLogix Packaged Controllers, Revision 18

Controller Catalog Numbers 1769-L23E-QB1B, 1769-L23E-QBFC1B, 1769-L23-QBFC1B

Publication 1769-RN013B-EN-P - November 2010

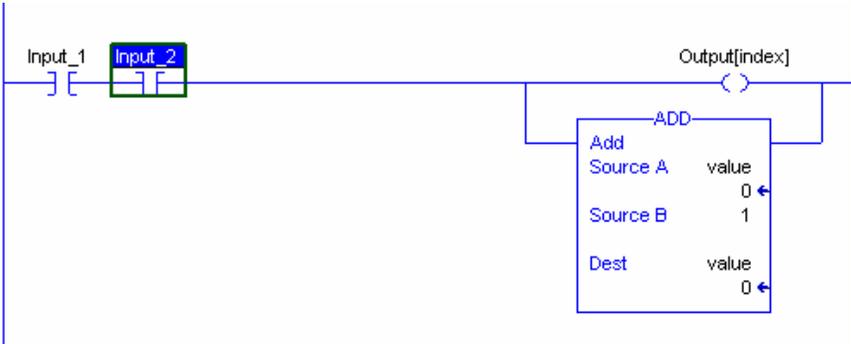
Cat No.	Description
1769-L23-QBFC1, 1769-L23E-QB1B, 1769-L23E-QBFC1B	<p>CORRECTED: Fault handlers can be defined at the controller and program scope levels. These fault handlers are typically used to handle major recoverable faults that can occur during runtime execution of an application due to programming errors. A typical example of this would be handling indirect addressing that has gone out of range; MyTag[index], where index is larger than the size of the array.</p> <p>Faults can also be handled by the controller during pre-scan of the controller program on the transition to Run mode. Again, for example, the handling of indirect addressing that has gone out of range.</p> <p>There is an anomaly when these methods attempt to handle a fault.</p> <p>These are the possible ways the anomaly can manifest itself:</p> <ul style="list-style-type: none"> • The controller will experience a Major Nonrecoverable Fault (MNRf). I/O goes to their configured safe state, and the user application is cleared from memory. At this point, a Code 1 Type 60 or 61 Major Recoverable Fault will be logged in the controller. This requires you to re-download the application. • Tag data corruption. • Online saving or uploading failures. • Anomalous program execution. <p>For example, if a rung is being scanned false and there is an instruction that has false execution, the fault handler executes so the remainder of the rung will scan true. In the example below, the OTE instruction has an index out of range. After returning from the fault handler, the ADD instruction will execute, even though the rung input conditions are false.</p>
