PLC-5/VME VMEbus Programmable Controllers

(Cat. No. 1785-V30B, -V40B, -V40L, and -V80B)

Introduction

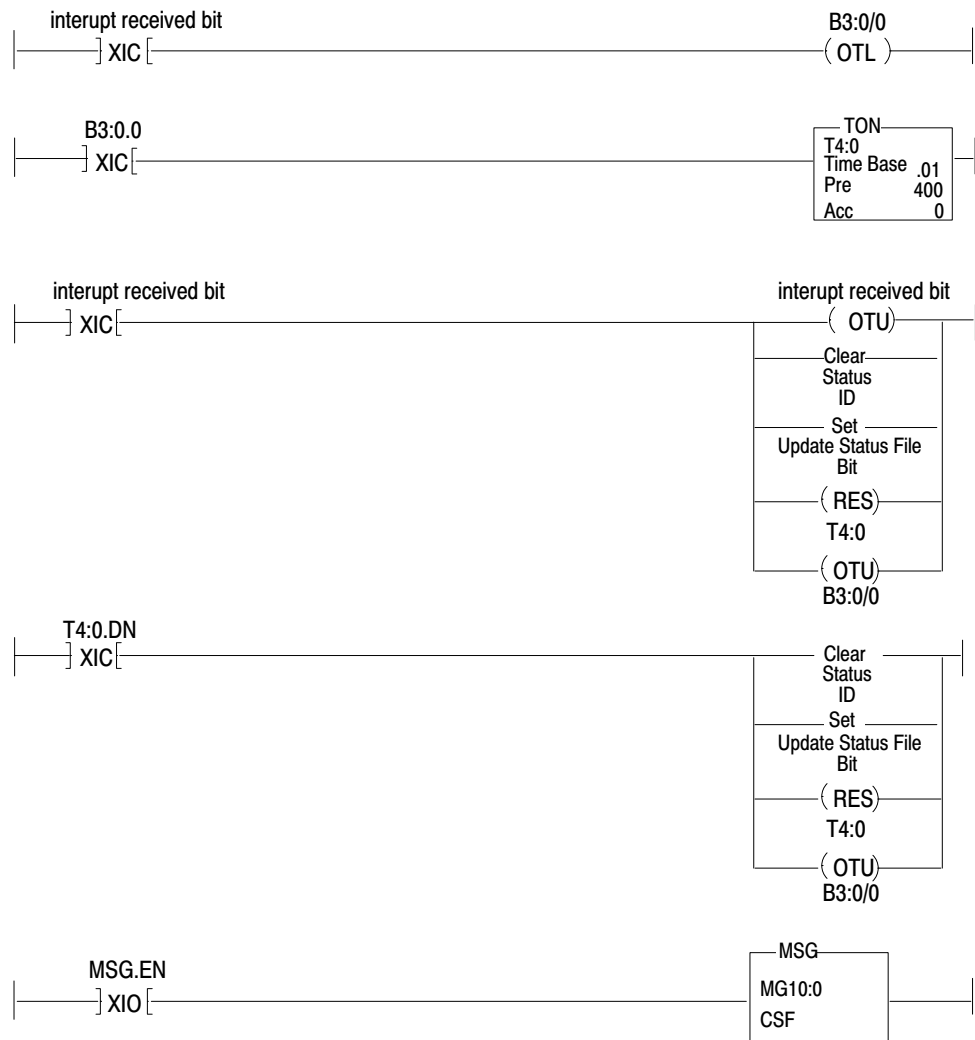
If you:

- set the NOCV bit to 1
AND
- use the VME interrupt receive bits in the VME status file

then you should implement ladder logic similar to the following example to avoid missing interrupts:

You may need to tune the value of the TON timer for each unique application.
