SoftLogix Controllers, Version 20

Catalog Numbers 1789-L10, 1789-L30, 1789-L60

This publication describes SoftLogix 5800 controllers, version 20.04.00.

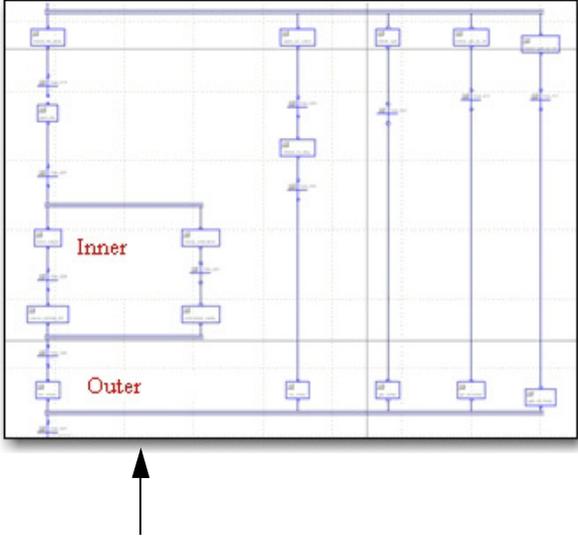
Cat. No.	Description
1789-L10, 1789-L30, 1789-L60	<p>CORRECTED: An anomaly can occur when you nest simultaneous branches in a Sequential Function Chart (SFC) routine as shown below.</p>

<p style="text-align: center;">Bottom-most Steps</p> <p>During normal operations, the logic does not step out of a simultaneous branch until all of the incoming legs have reached their bottom-most step. In the example shown, the logic does not step out of the Outer simultaneous branch until the leftmost leg has stepped out of the Inner simultaneous branch. The first time through the SFC routine, the application works as expected. On subsequent scans, however, the chart steps out of the Outer simultaneous branch even though the left leg has not reached the Inner simultaneous branch yet.</p> <p>This behavior occurs because the information in the bottom step, that is, the step next to the word Outer, remains from the previous scan. This stale information incorrectly causes the transition to move on as if the left leg is at the bottom step when it actually is not.</p> <p>To work around this anomaly, confirm all of the incoming legs have reached their bottom steps in the transition. You can check the .x bits to make sure the bottom-most step of each converging leg is active before allowing the chart to advance. This check can be added to the transition logic already present. For example, the steps in the following expression are the bottom steps (see graphic above) of the incoming legs. Each step has a timer. The transition does not move on until all of the step timers have reached their preset value.</p> <p>The expression can be modified to be sure those steps are truly active. This is the original expression:</p> <pre>// Unit is ready to Transition Step1_ready.dn and Step2_ready.dn and Step3_ready.dn and Step4_ready.dn and Step5_ready.dn</pre> <p>This is the modified expression to work around this anomaly.</p> <pre>// Unit is ready to Transition Step1_ready.x and Step2_ready.x and Step3_ready.x and Step4_ready.x and Step5_ready.x and Step1_ready.dn and Step2_ready.dn and Step3_ready.dn and Step4_ready.dn and Step5_ready.dn</pre> <p>IMPORTANT: The x bit is cleared when the chart transitions out of a step.</p> <p>Adding this check to the condition forces the engine to wait until all of those steps are genuinely active before advancing out of the simultaneous branch. Lgx00118188, Lgx00116506</p> <hr/> <p>CORRECTED: Executing a Home Command (MAH) could cause unintended motion, equal to the negative unwind distance, when the controller executes the final offset move to the home position. The Conversion Constant and the Drive Resolution are the main contributor along with being a rotary axis. Other parameter settings that contribute to this condition are as follows:</p> <ul style="list-style-type: none"> - Home Mode = Active - Home Sequence = Marker or Switch-Marker - Home Offset = Small incremental distance (that is, 5 degrees) - Rotary Configuration with an unwind <p>To solve, upgrade to revision 20 of ControlLogix controllers, or for earlier revision periods to revision 20, set the Home Offset position to 0, use a MAM instruction to move the offset distance, then MRP (Motion Redefine Position) to the home position. Lgx00124698, Lgx00123947</p>

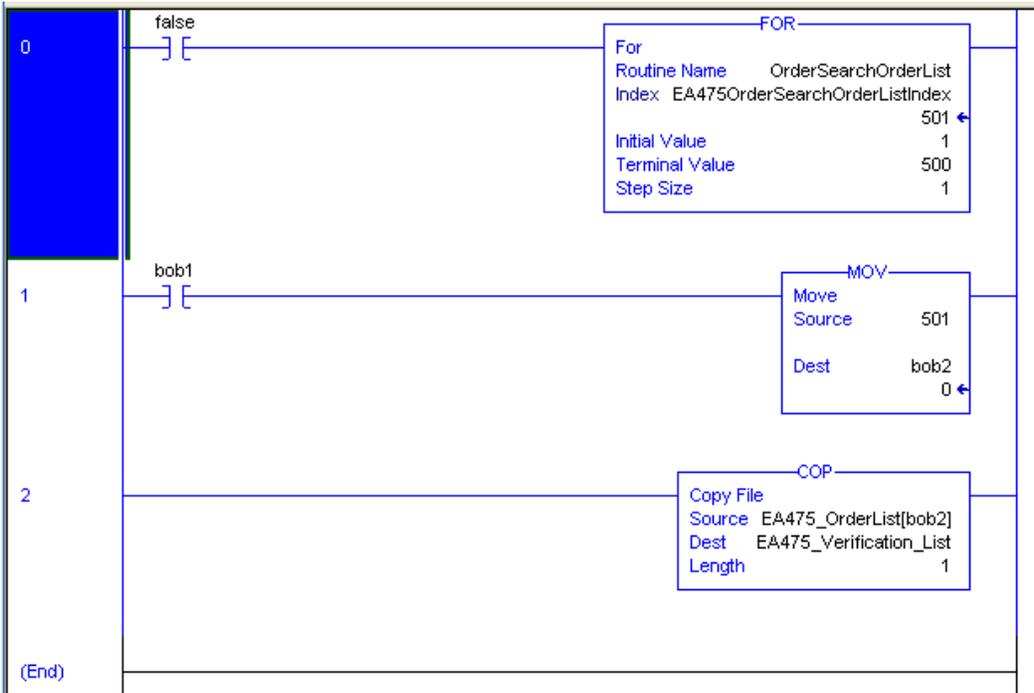
Cat. No.	Description
1789-L10, 1789-L30, 1789-L60	<p>CORRECTED: If a FOR instruction is scanned true and an instruction has an index out of range that references a UDT or multi-dimensional array, the controller will fault. Clearing the fault and returning to run mode will cause a nonrecoverable major fault.</p>
