FlexLogix Controller, Revision 16

Catalog Number 1794-L34

About Publication 1794-RN016E

Publication 1794-RN016E-EN-P - February 2010

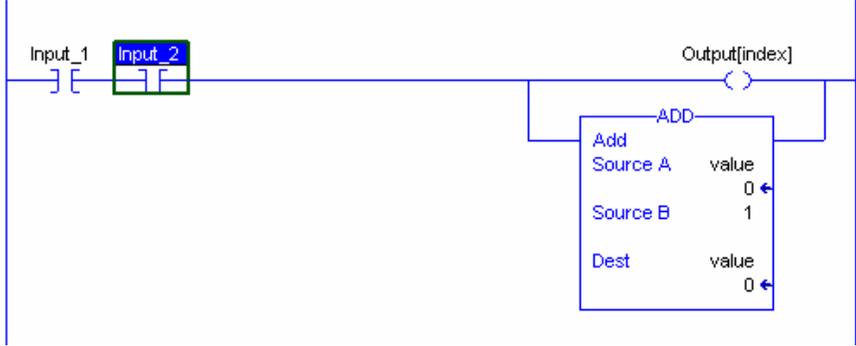
Firmware Revision	Description
16.22	<p>Fault handlers can be defined at the controller and program scope levels. These fault handlers are typically used to handle major recoverable faults that can occur during runtime execution of an application due to programming errors. A typical example of this would be handling indirect addressing that has gone out of range; MyTag[index], where index is larger than the size of the array.</p> <p>Faults can also be handled by the controller during pre-scan of the controller program on the transition to Run mode. Again, for example, the handling of indirect addressing that has gone out of range.</p> <p>There is an anomaly when these methods attempt to handle a fault.</p> <p>These are the possible ways the anomaly can manifest itself:</p> <ul style="list-style-type: none"> • The controller will experience a major non-recoverable fault. I/O goes to their configured safe state, and the user application is cleared from memory. At this point, a Code 1 Type 60 or 61 major recoverable fault will be logged in the controller. This requires you to reupload the application. • Tag data corruption. • Online saving or uploading failures. • Anomalous program execution. <p>For example, if a rung is being scanned false and there is an instruction that has false execution, the fault handler executes so the remainder of the rung will scan true. In the example below, the OTE instruction has an index out of range. After returning from the fault handler, the ADD instruction will execute, even though the rung input conditions are false.</p>

<p>Lgx00106481, Lgx00107423, Lgx00100766, Lgx00106478</p>
