## PanelView 1200 Operator Terminals

2711-KA1, KC1, TA1, TC1, TA4, TC4 Series F

Firmware Release Version 5.10.00, 5.13.00

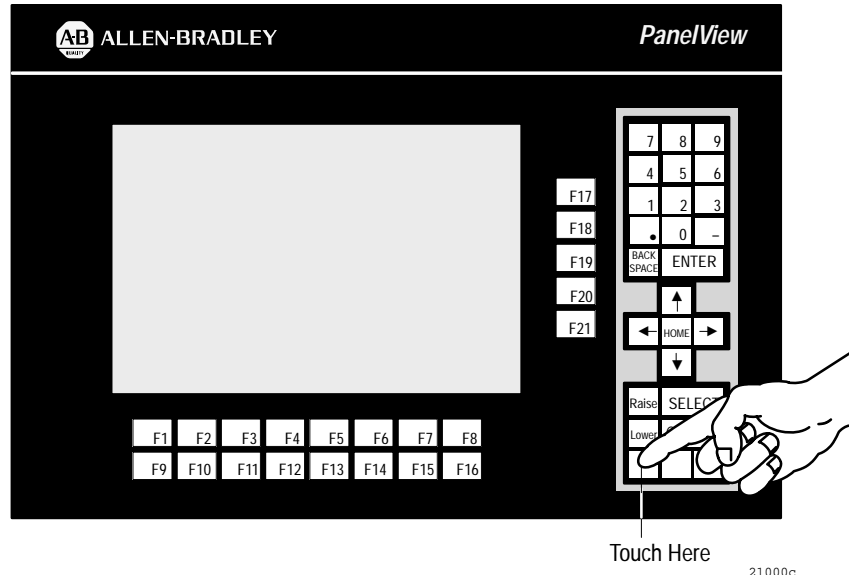
### If you installed Touch Screen Firmware on a Keypad Terminal:

- 2 Press the leftmost unmarked gray button (below the Lower button).

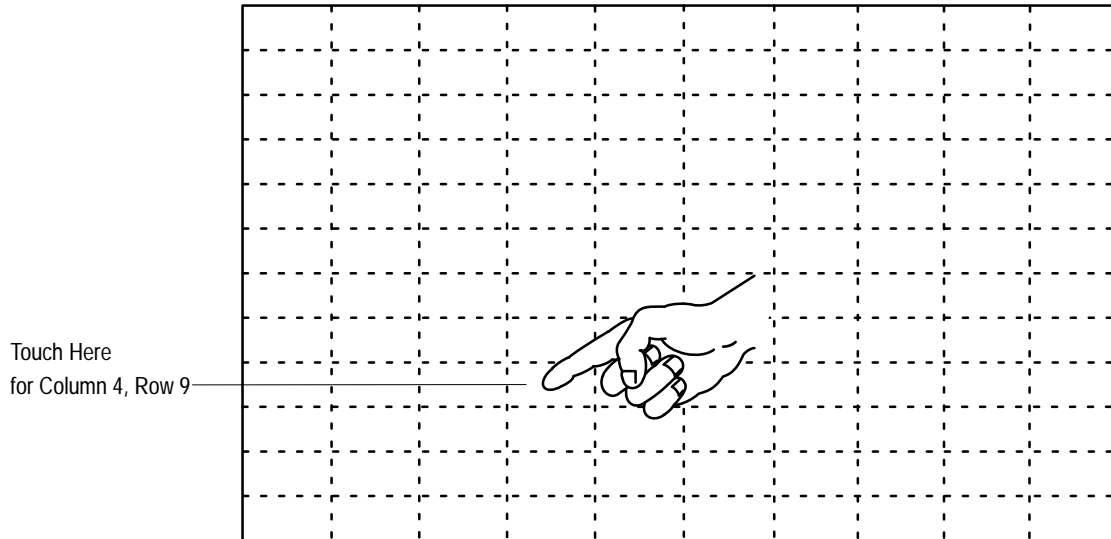
**If you installed Keypad Firmware on a Touch Screen Terminal:**

- If the terminal is powered up in configure mode, press the touch cell at Column 4 and Row 9 (the point of origin is at the top left of the touch screen). This will clear the error message at the bottom of the screen.

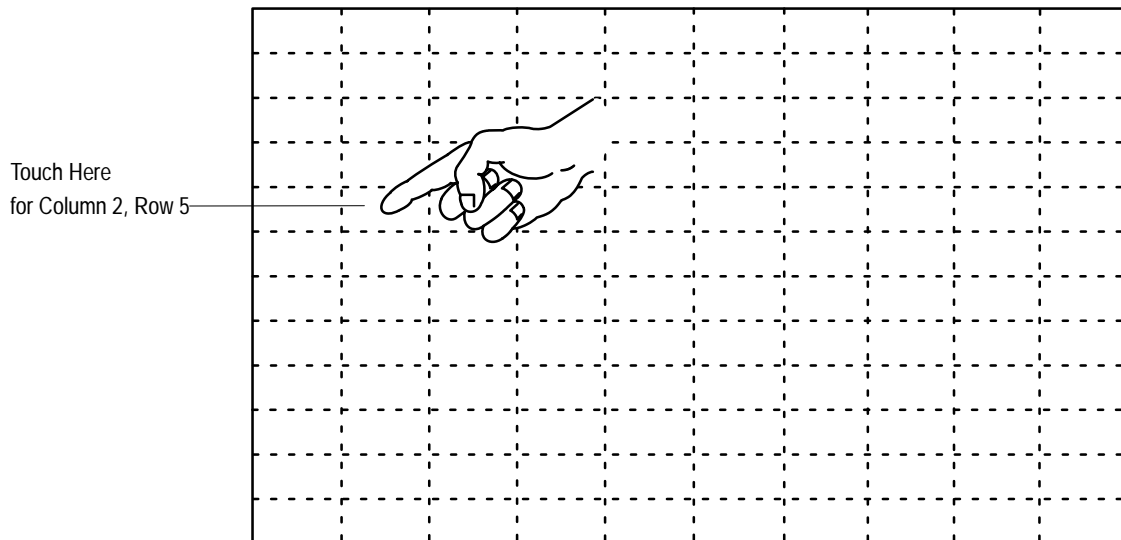
**2 Press the touch cell at Column 2 and Row 5**
