Allen-Bradley

***1395 Digital
DC Drive***

Troubleshooting Manual

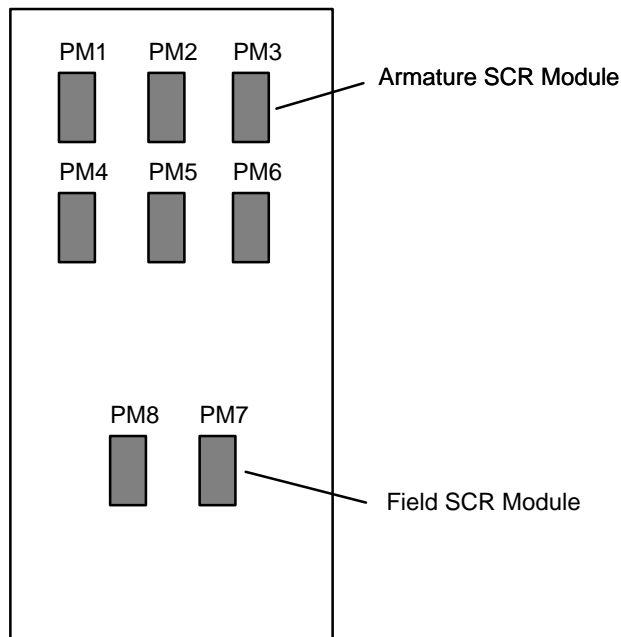
SCR Layout Series A

1. Disconnect and lock-out ALL incoming voltage sources. Verify that the three-phase high voltage is removed from the incoming protection devices, either F1 - F3 or the main circuit breaker CB1. Also verify that the 115V logic supply and contactor power is removed from TB2-3,4, and 5. If an external field supply is used, verify that it is also removed by checking TB1-1 and 5.
2. Check the Anode to Cathode junction of each SCR module. With a DVM on the 1 Megohm scale, measure the resistance across the SCR modules as follows: (Note: Lead orientation is not critical)

PM1 - Upper left SCR module;

All resistances should be 100kohms or greater. If a low resistance is detected replace the affected SCR pack.

Armature SCR's (Series A) – The 1395, 1–100 HP 230 VAC/ 2 – 200 HP 460VAC, armature supply consists of six dual pack SCR modules mounted on the main heat sink. A malfunction of any of these devices will show itself in either an overcurrent related fault, blown or tripped incoming protection devices, or erratic motor operation. The following procedure can be used if an armature bridge component malfunction is suspected.

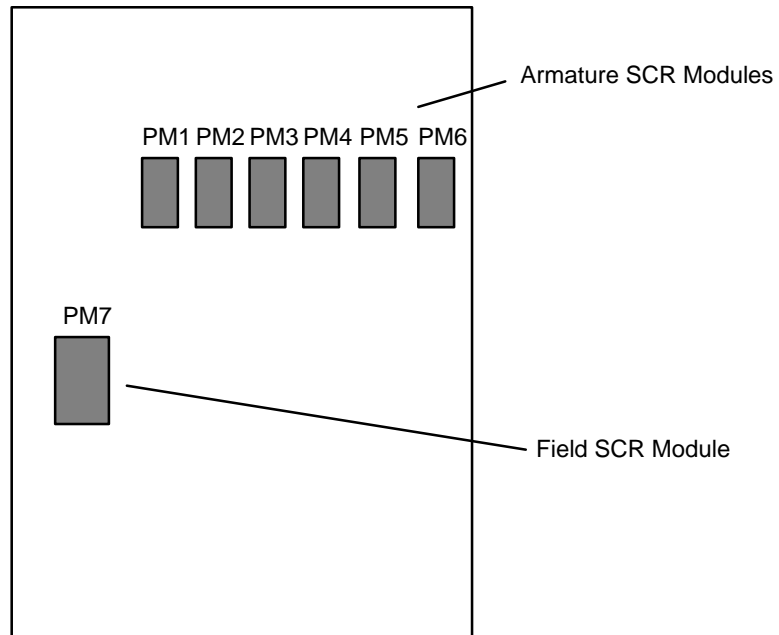
SCR Layout Series B

1. Disconnect and lock-out ALL incoming voltage sources. Verify that the three-phase high voltage is removed from the incoming protection devices, either F1 - F3. Also verify that the 115V logic supply and contactor power is removed from TB2-1, 2, 3. To gain access to the Power Board, swing down and remove PSI/Switcher Board.
2. Check the Anode to Cathode junction of each SCR module. With a DMM on the 1 Megohm scale, measure the resistance across the SCR modules as follows:

- PM1 - left SCR module; to PM2 2nd SCR module
A1 (bottom of DC contactor) to L1 (bottom of F1)
A2 (bottom of DC contactor) to L1 (bottom of F1)
- PM3 - 3rd SCR module to PM4 4th SCR module
A1 (bottom of DC contactor) to L2 (bottom of F2)
A2 (bottom of DC contactor) to L2 (bottom of F2)

Armature SCR's Series B – The 1395, 1–30 HP 230 VAC/ 2 – 60 HP 460VAC armature supply consists of six dual pack SCR modules mounted on the main heat sink. A malfunction of any of these devices will show itself in either an overcurrent related fault, blown or tripped incoming protection devices, or erratic motor operation. The following procedure can be used if an armature bridge component malfunction is suspected.
