1395 Troubleshooting Guide

Malfunctions Not Indicated by a Fault

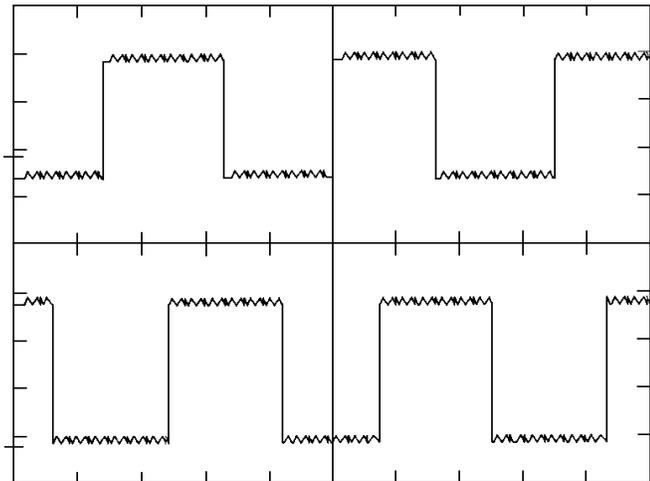
Figure 3.1
Waveform 1 - Encoder Phases A (TP15)
and B (TP12), Forward (CCW)

Solution: Open the drive door and lower the Main Control Board assembly. Locate test points TP12 and TP15 on the left side of the board near U13. TP12 is the phase B signal and TP15 is the phase A. Verify that proper quadrature exists between A and B. Rotate the motor in the CCW direction, as viewed from the commutator. The resulting waveform should be similar to Waveform 1 shown in Figure 3-1. If the encoder signals are in phase or 180 Deg out of phase, check the wiring to ensure that the signal lines are not shorted. If the wiring is functional replace the encoder.

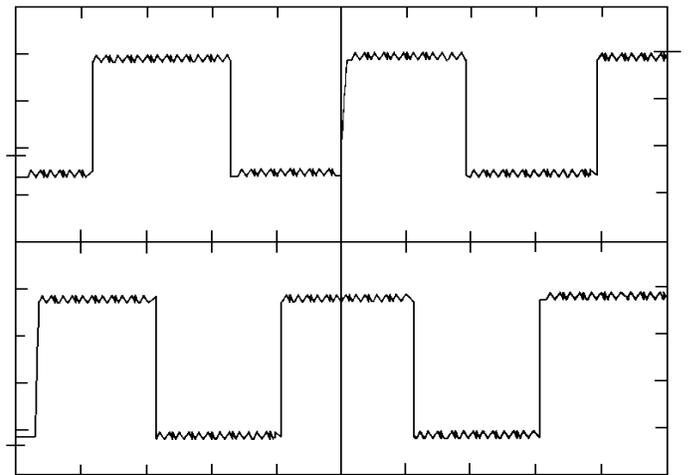
Figure 3.2
Waveform 2 - Encoder Phases A (TP15)
and B (TP12), Reverse (CW)

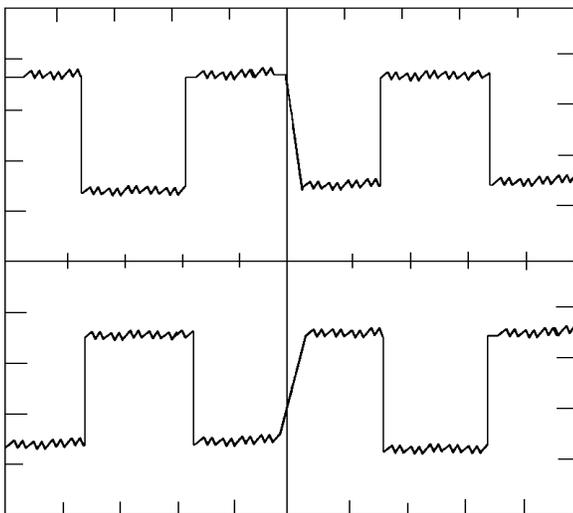
Figure 3.3
Waveform 3 - Encoder Signals A (TB3-20)
and A (NOT) (TB3-19)

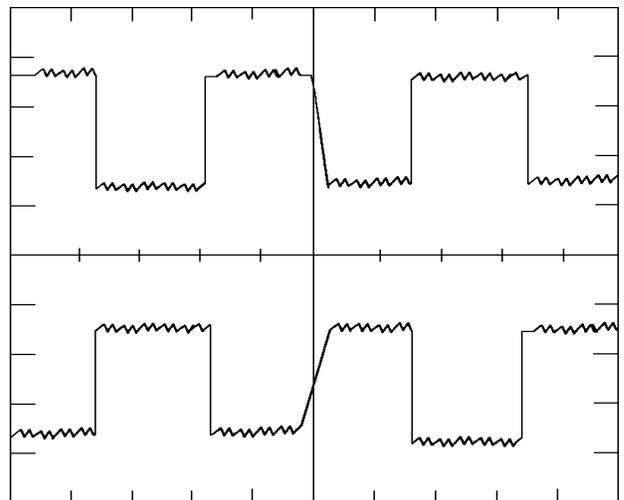
Figure 3.4
Waveform 4 - Encoder Signals B (TB3-18)
and B (NOT) (TB3-17)

Solution: Measure the encoder output signals at the 1395 terminal strip. Place a scope probe at TB3-17 and at TB3-18 and reference them to TE. These signals represent the differential channel outputs for phase B. TB3-17 is inverted and TB3-18 is non-inverted. Rotate the shaft of the motor, either by mechanical means or under armature voltage feedback control. The resulting waveform should be similar to Waveform 3. If the proper signal is not observed, replace the encoder. Note: If using armature voltage feedback to troubleshoot the encoder, the set-up procedure for armature voltage feedback must be performed first for proper operation. Use the same method to check phase A of the encoder output. Place a scope probe at TB3-19 and TB3-20 and reference them to TE. TB3-19 is inverted and TB3-20 is non-inverted. Rotate the shaft of the motor, either by mechanical means or under armature voltage feedback control. The resulting waveform should be similar to Waveform 3. If the proper signal is not observed, replace the encoder.

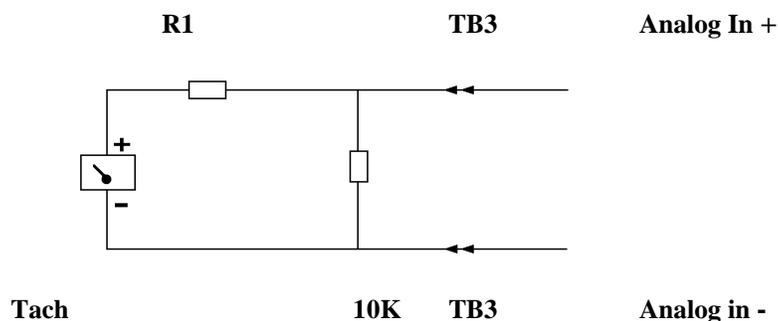
20K Adapter Board Input Impedance

This circuit uses a 10K resistor across the input channel and R1 represents the dropping resistor for the scaling network. To determine the value of R1 use the following equation:

$$\frac{(\text{Max Volts output}) \times 620}{9V} - 6250 = R1$$

The analog tachometer device generates a DC voltage that is direction sensitive and proportional to speed. The tach output must be connected to an analog input channel on the Discrete Adapter Board. Most industrial tachs have an output greater than the +/- 10V range of the analog inputs. The tach output must be scaled down, by an external voltage divider network (see Figure 6.22).

1. Determine the Volts/RPM rating of the tach. It is usually on the tach nameplate. Multiply this rating times the absolute maximum speed the motor will be commanded to accelerate to. (This value should also be programmed in Parameter 607 “Rev Speed Lim” and 608 “Fwd Speed Lim” to ensure the velocity command will be properly clamped).
2. This Max Volts output must be scaled to a level within the +/- 10V analog input channel range. This can be accomplished by using a voltage divider that will take the Max Volts output and scale it to a maximum 9V input. This allows for protection against 10% overshoot.

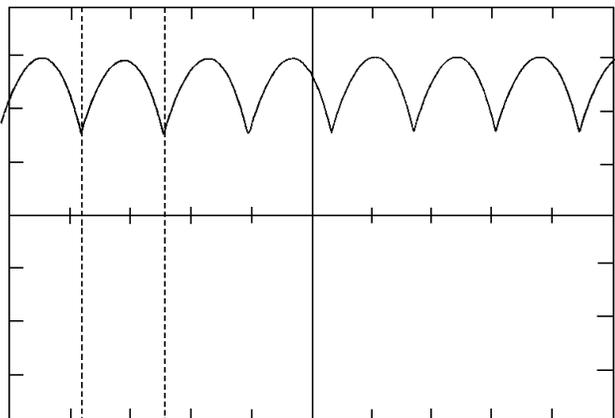
Figure 3.5
Waveform 5 - Armature Current Feedback
(TP2) - Continuous Current

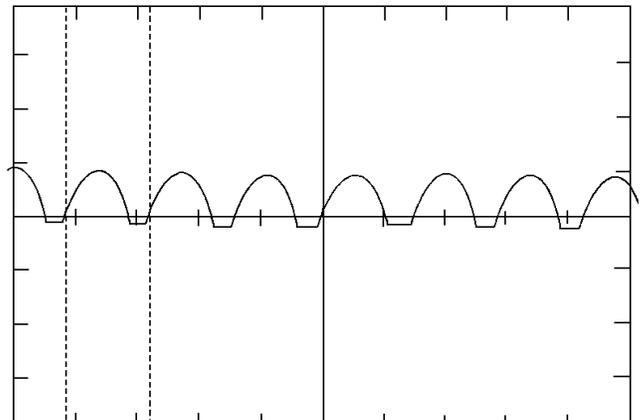
Figure 3.6
Waveform 6 Armature Current Feedback
(TP2) - Discontinuous Current

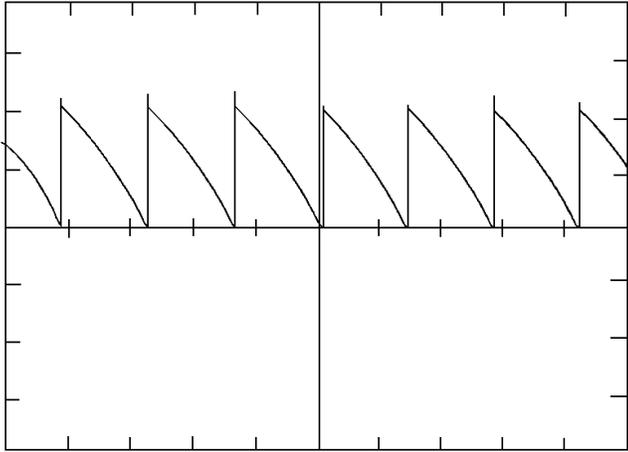
Figure 3.7
Waveform 9 - Armature Voltage Feedback
(TP21) - Motoring Forward

TP21 - Armature Voltage Feedback is sensed at the output side of the DC contactor. It is scaled down to a +/- 10V signal and accurately reflects the voltage waveform across the motor armature. The waveform measured at TP21 is inverted in respect to the actual voltage across A1 to A2. Either an oscilloscope (preferred) or a DVM can be used to monitor this signal with respect to AGND (TP57). It is scaled on the low voltage drive (150- 300V DC) as 1V signal = 65V armature voltage. The high voltage drive (300-500V DC) is scaled as 1V signal = 125V armature voltage. The waveforms shown in Figures 3-5 through 3-11 represent the typical signal that occurs during the four quadrants of bridge operation.

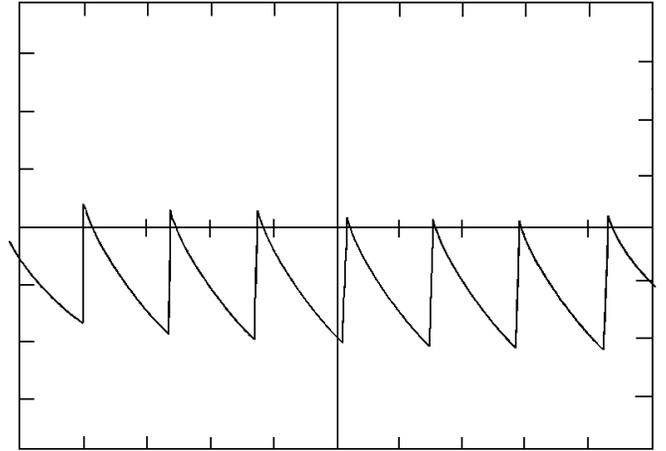
Figure 3.8
Waveform 8 - Armature Voltage Feedback
(TP21) Regen Forward

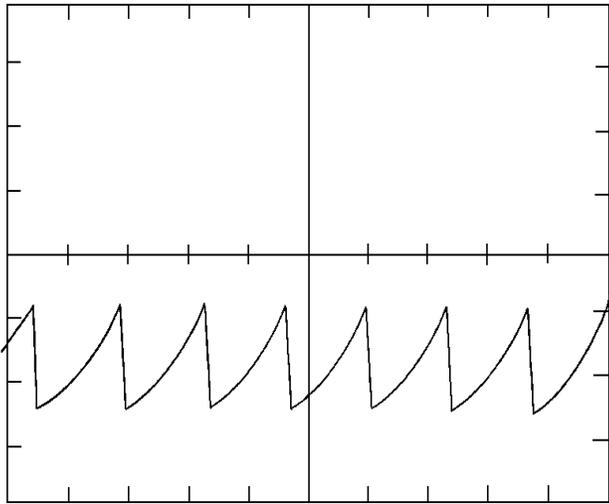
Figure 3.9
Waveform 7 - Armature Voltage Feedback
(TP21) Motoring Reverse

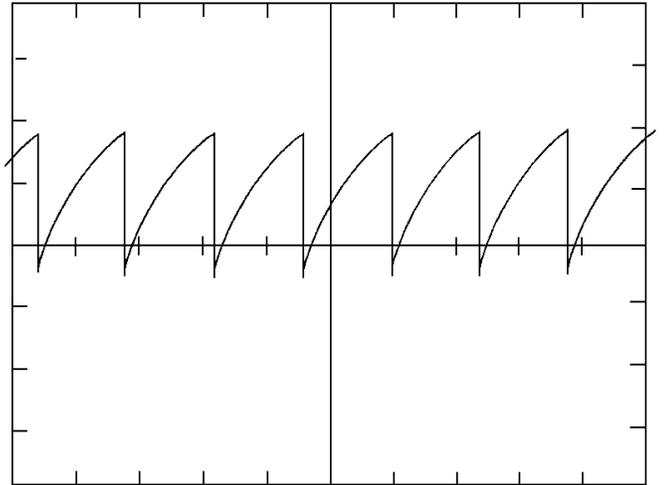
Figure 3.10
Waveform 10 - Armature Voltage Feedback
(TP21) Regen Reverse

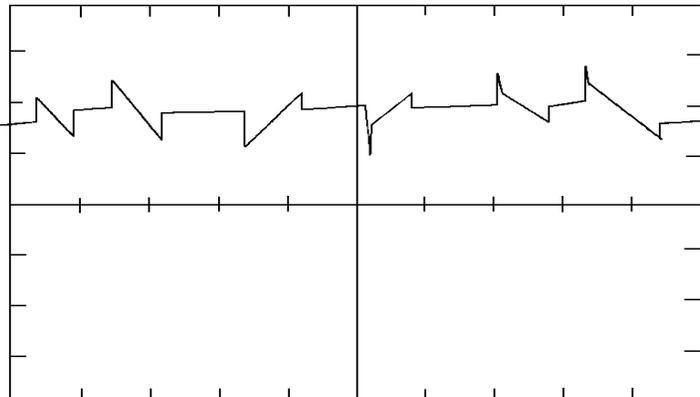
Figure 3.11
Waveform 11 - Armature Voltage Feedback
(TP21) Constant Velocity w/No Load

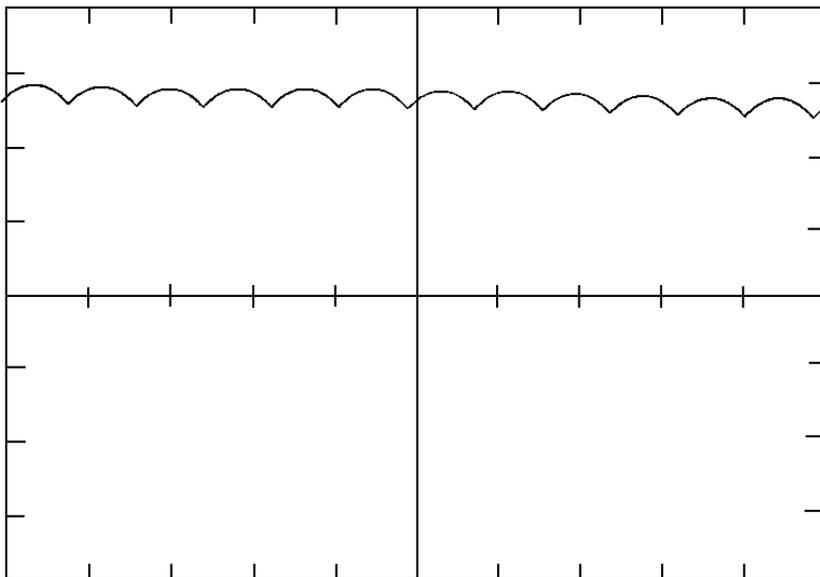
Figure 3.12
Field Current Feedback (TP25) - Continuous Current

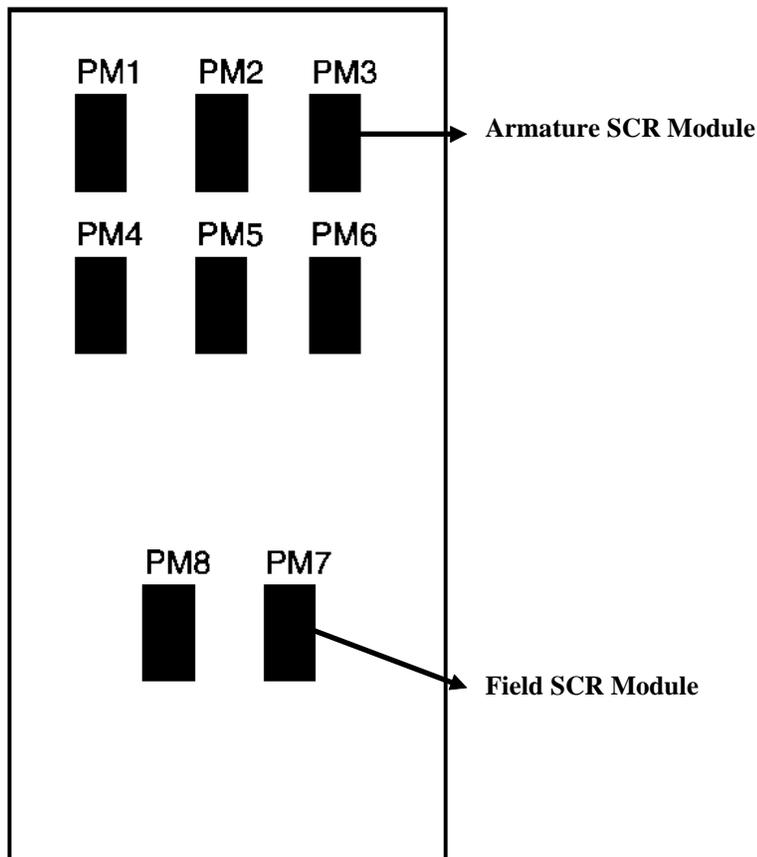
SCR Layout Series A

- PM1 - Upper left SCR module;
A1 (Bottom of DC contactor) to L1 (bottom of F1)
- PM2 - Upper middle SCR module;
A 1 (bottom of DC contactor) to L2 (bottom of F2)
- PM3 - Upper right SCR module;
A1 (bottom of DC contactor) to L3 (bottom of F3)
- PM4 - Lower left SCR module;

All resistance's should be 100kohms or greater. If a low resistance is detected replace the affected SCR pack.

All resistance's should be between 7 to 30 ohms. If a measurement is outside of this range or if one reading deviates significantly from the majority, then module replacement may be necessary.

The 1395, 1-100 HP 230 VAC/ 2 - 200 HP 460VAC, armature supply consists of six dual pack SCR modules mounted on the main heat sink. A malfunction of any of these devices will show itself in either an overcurrent related fault, blown or tripped incoming protection devices, or erratic motor operation. The following procedure can be used if an armature bridge component malfunction is suspected.

1. Disconnect and lock-out ALL incoming voltage sources. Verify that the three-phase high voltage is removed from the incoming protection devices, either F1 - F3 or the main circuit breaker CB1. Also verify that the 115V logic supply and contactor power is removed from TB2-3,4, and 5. If an external field supply is used, verify that it is also removed by checking TB1-1 and 5.
2. Check the Anode to Cathode junction of each SCR module. With a DVM on the 1 Meg ohm scale, measure the resistance across the SCR modules as follows: (Note: Lead orientation is not critical)

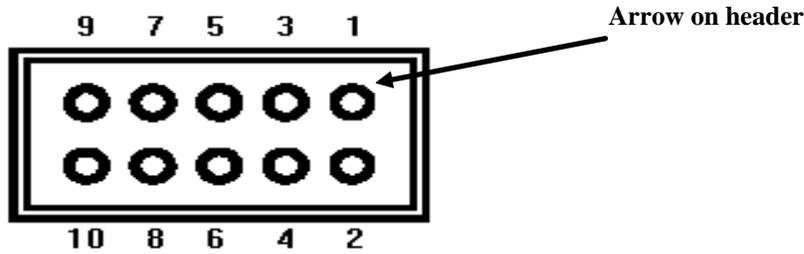
J1 Pin Orientation (Top View)

G1 (upper) to DCA1 should be 100 ohms +10%
G1 (lower) to DCA2 should be 100 ohms +10%
G2 (upper) to AC (2L1) should be 100 ohms +10%
G2 (lower) to AC (3L1) should be 100 ohms +10%
D1 (anode) to DCA1 should be 1 to 2 ohms
D2 (anode) to AC (2L1) should be 1 to 2 ohms
D3 (anode) to AC (3L1) should be 1 to 2 ohms
D4 (anode) to DCA2 should be 1 to 2 ohms
J1-1 to J1-8 should be 100 ohms +10% (see below)
J1-2 to J1-8 should be 100 ohms +10% (see below)
J1-3 to J1-8 should be 100 ohms +10% (see below)
J1-6 to J1-8 should be 100 ohms +10% (see below)

1. Disconnect and lock-out ALL incoming voltage sources.(See above)
2. Remove all three Pulse Boards by disconnecting the ribbon cable at J1 and remove the upper and lower gate leads at G1 and G2. Loosen the captive thumb screws designated DCA1, AC, and DCA2. Measure the following resistance's with the DVM on the 200 ohms scale. (Note lead orientation is not critical)

3. If any of these measurements (G1 through J6) are out of tolerance, replace the associated board. If these procedures check out and no apparent discrepancies are found, a potential problem could still exist. If a “breakdown path” has been established from the pulse transformer primary to secondary, it is possible that a malfunction could show itself when the line voltage potential is applied to the power structure. This condition can only be detected by “hi potting” the board at a level of 2500Vrms, and verifying less than 5mA from primary to secondary.

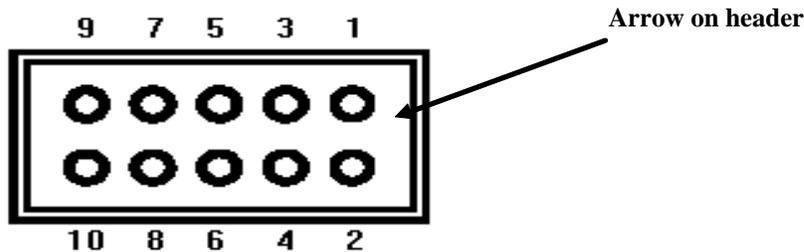
J1 Pin Orientation (Top View)

L1 to D3 (cathode) should be 100 ohms +/- 10%
L1 to D3 (anode) should be 1 to 2 ohms
F1 to D4 (cathode) should be 100 ohms +/- 10%
F1 to D4 (anode) should be 1 to 2 ohms
L3 to D2 (cathode) should be 100 ohms +/- 10%
L3 to D2 (anode) should be 1 to 2 ohms
F1 to D1 (cathode) should be 100 ohms +/- 10%
F1 to D1 (anode) should be 1 to 2 ohms
J1 - 1 to J1-9 should be 60 ohms +/- 10%
J1 - 1 to J1-10 should be 60 ohms +/- 10%

1. Disconnect and lock-out ALL incoming voltage sources.(See above)
2. Remove the pulse/snubber board by disconnecting the ribbon cable at J1 and remove the left and right gate leads at G1 and G2. Loosen the captive thumb screws and remove the printed circuit board. Measure the following resistance's with the DVM on the 200 ohms scale. (Note lead orientation is not critical)

If any of these measurements are out of tolerance, replace the associated board. If the above procedure checks out and no apparent discrepancies are found, a potential problem could still exist. If a “breakdown path” has been established from the pulse transformer primary to the secondary, it is possible that a malfunction could show itself when the line voltage potential is applied to the power structure. This condition can only be detected by “hi potting” the board at a level of 2500V rms, and verifying less than 5mA from primary to secondary.

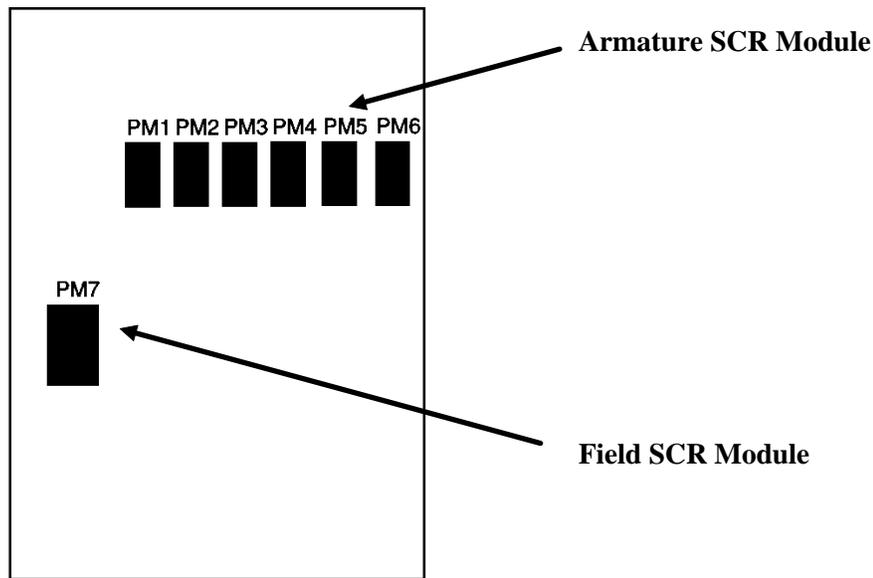
PM1 - left SCR module; to PM2 2nd SCR module
 A1 (bottom of DC contactor) to L1 (bottom of F1)
 A2 (bottom of DC contactor) to L1 (bottom of F1)
 PM3 - 3rd SCR module to PM4 4th SCR module
 A1 (bottom of DC contactor) to L2 (bottom of F2)
 A2 (bottom of DC contactor) to L2 (bottom of F2)
 PM5 - 5th SCR module to PM6 Right SCR module
 A1 (bottom of DC contactor) to L3 (bottom of F3)
 A2 (bottom of DC contactor) to L3 (bottom of F3)

All resistance's should be 100K ohm or greater. If a low resistance is detected, remove the power board and determine which of the power module pair is bad, replace it accordingly.

1. Disconnect and lock-out ALL incoming voltage sources. Verify that the three-phase high voltage is removed from the incoming protection devices, either F1 - F3. Also verify that the 115V logic supply and contactor power is removed from TB2-1, 2, 3. To gain access to the Power Board, swing down and remove PS1/Switcher Board.
2. Check the Anode to Cathode junction of each SCR module. With a DMM on the 1 Megohm scale, measure the resistance across the SCR modules as follows:
