SLC 5/03™ and SLC 5/04™ Processors Firmware/Operating System Upgrade

Introduction

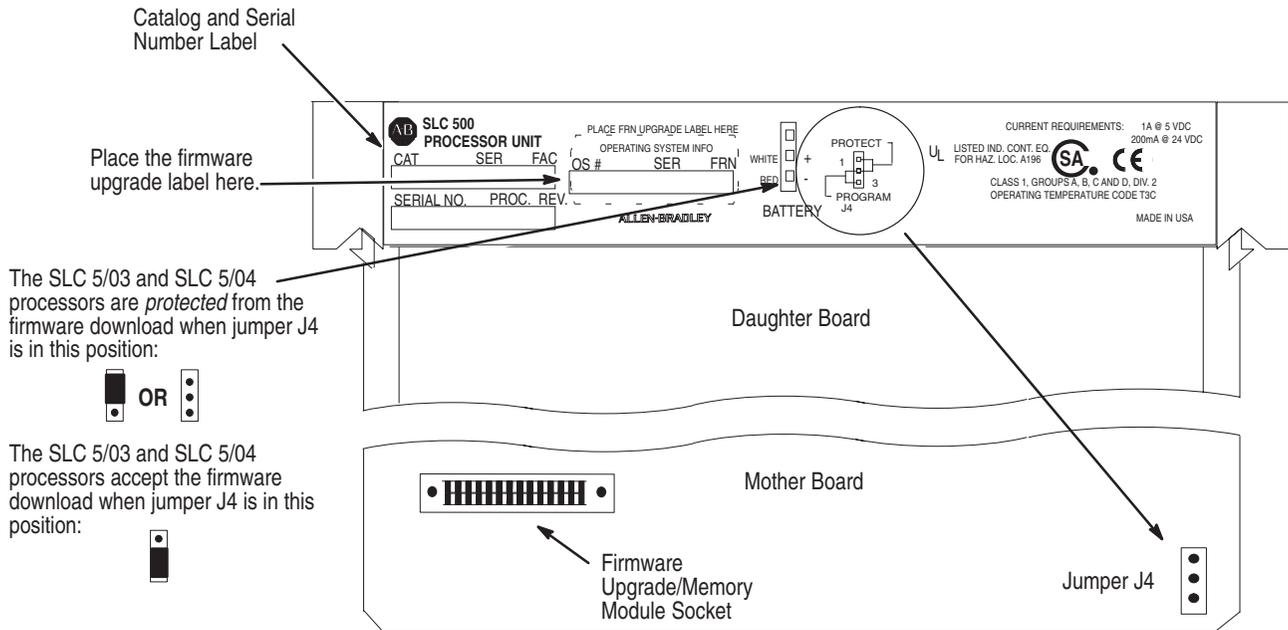
Figure 1 Component Placement Information

Jumper J4, located in the bottom right corner of the motherboard, provides write protection from any download of a new operating system. The “out of the box” position of this jumper is “PROTECT,” or write protect. Without the jumper, the processors are write protected.

Follow these instructions carefully. Refer to page 3 for component placement information.

Failure to return the J4 jumper to the protected position results in an error (0x3D Hex) on the power cycle following the download of a valid program to the processor. This error condition prevents the module from going to run and causes Channel 0 communication settings to return to their defaults. To properly clear the error, place the J4 jumper in the protected position, and then re-download a valid user program to the processor.

The Following Error Exists	Probable Cause	Recommended Action
Memory Write Protected	An attempt was made to download the operating system onto write-protected memory.	Change the J4 jumper of the SLC 5/03 and SLC 5/04 processors to the program position.
