## **ControlLogix® Controller Revision 11**

Cat. No. 1756-L1, -L1M1, -L1M2, -L1M3, -L55, -L55M12, -L55M13, -L55M14, -L55M16, -L55M22, -L55M23, -L55M24, -L63

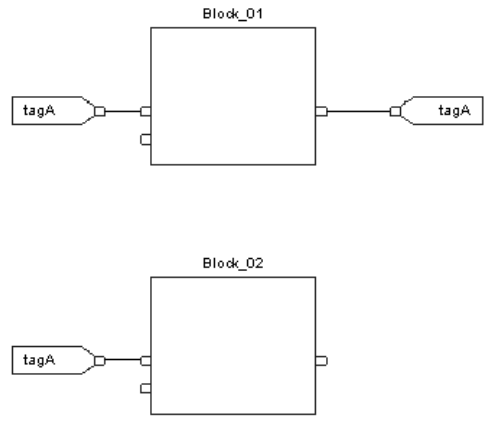
<b>Change:</b>	<b>Description:</b>
Use the Same Tag in Multiple IREFs and OREFs	<p>You can use the same tag in multiple IREFs and an OREF in the same routine. Because the values of tags in IREFs are latched every scan through the routine, all IREFs will use the same value, even if an OREF obtains a different tag value during execution of the routine. In this example, if tagA has a value of 25.4 when the routine starts executing this scan, and Block_01 changes the value of tagA to 50.9, the second IREF wired into Block_02 will still use a value of 25.4 when Block_02 executes this scan. The new tagA value of 50.9 will not be used by any IREFs in this routine until the start of the next scan.</p>
