ControlLogix DeviceNet Interface Module

Catalog Number 1756-DNB

About This Publication

This release note provides revision information for this module. This release note corresponds to module revisions 7.001 and earlier.

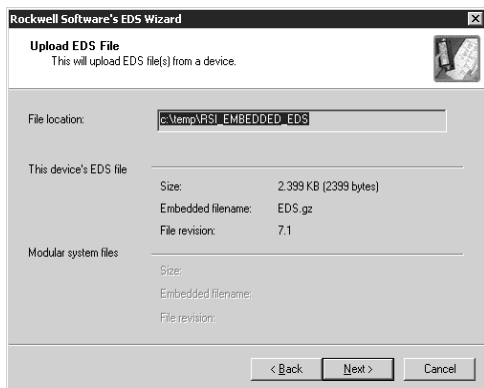
1. In RSNetWorx for DeviceNet software, right-click on the unrecognized device and choose Register Device.
2. Click Next.
3. Choose the Upload EDS file(s) from the device option.
4. Click Next.

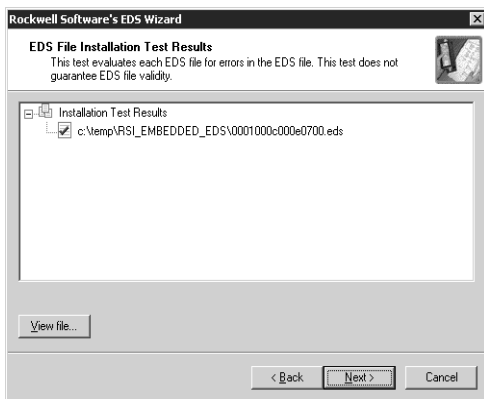
RSNetWorx software uploads the EDS file from the device. When the upload is completed, you see a dialog box similar to this one:

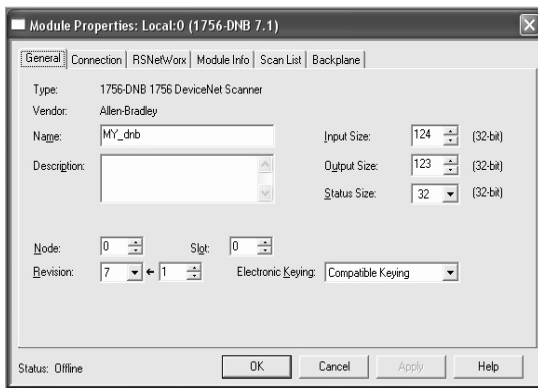
1. Start RSLogix 5000 software.
2. While offline, open a preconfigured RSLogix 5000 program that contains your 1756-DNB module.
3. Right-click on the module and choose Properties.
4. Select Compatible Keying.

If Electronic Keying Is	Do This
Compatible Keying	No changes are needed.
Exact Match	1. Choose Compatible Keying from the pull-down menu. 2. Click Apply.

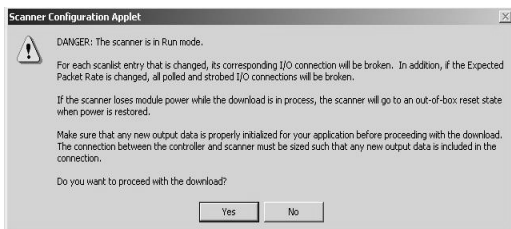
You see a warning message telling you the 1756-DNB module is in Run mode, and asking you to verify the download.

For each scanlist entry that is changed, its corresponding I/O connection will be broken. If the requested packet interval (RPI) is also changed, all polled and strobed I/O connections will be broken.
