## **ControlLogix DeviceNet Interface Module**

Catalog Number 1756-DNB

### **Use These Release Notes**

These release notes describe changes in firmware revision 5.002 and earlier of the ControlLogix DeviceNet Interface Module, catalog number 1756-DNB, Series A.

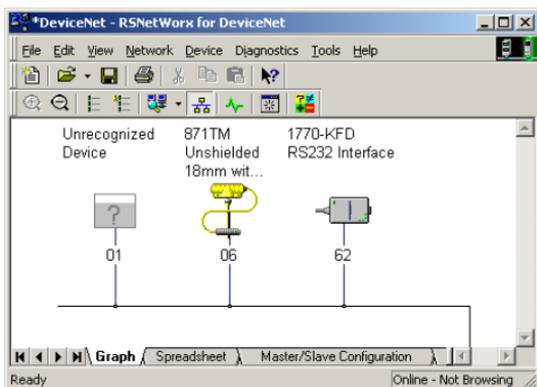
While browsing the DeviceNet network in RSNetWorx v5, Node #1 shows up as an Unrecognized Device. You know that Node #1 is in fact a 1756-DNB version 5, but you have not yet downloaded and installed the updated EDS file for it.

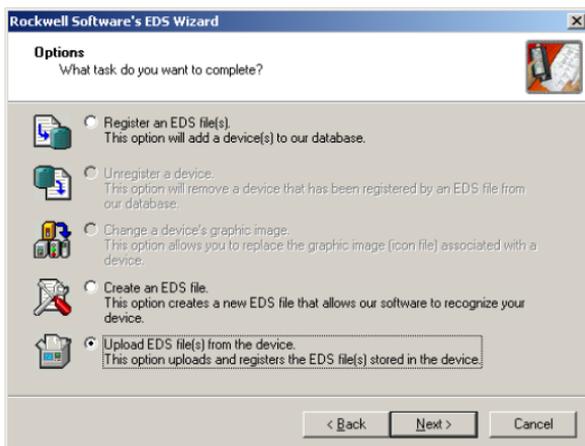
You see the following dialog box:

3. Choose the 'Upload EDS file(s) from the device' option.
4. Click on 'Next'.

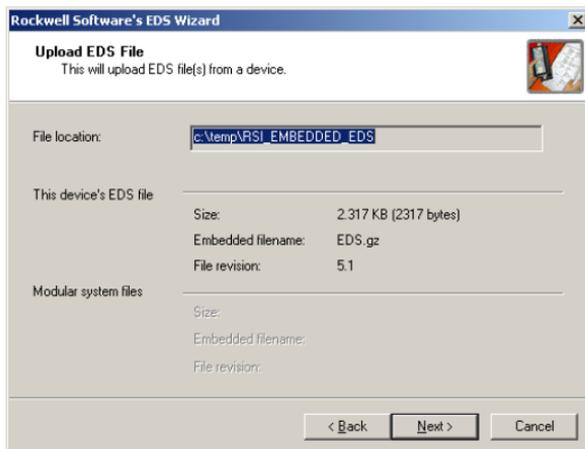
RSNetWorx uploads the EDS file from the device and, when the upload is completed, you see a similar dialog box:

5. Click on 'Next'.

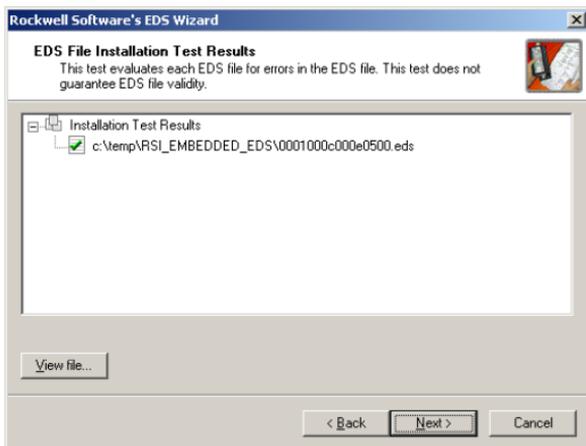
You see the status of the EDS installation:

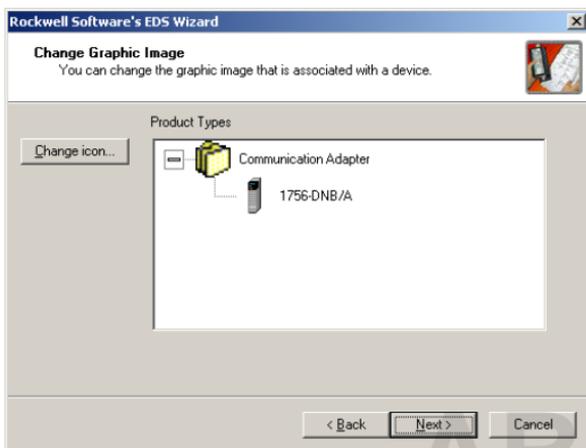
You see the following informational dialog box:

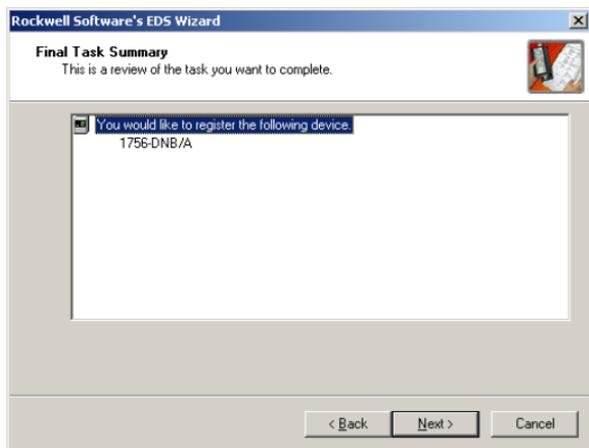
You see the following informational dialog box:

8. Click on 'Next', and then 'Finish'.
