# ControlLogix® 5560M03SE Combination Controller and SERCOS interface Revision 13

Cat. No. 1756-L60M03SE

## When to Use These Release Notes

Controller:	Catalog number:	Revision:
ControlLogix5560M03SE	1756-L60M03SE	13.6

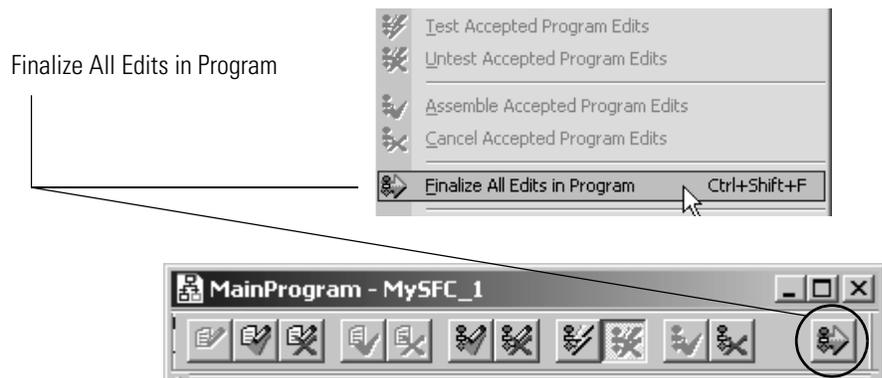
Online Edits of Sequential Function Charts (SFC) and Structured Text (ST)	This revision lets you perform online editing of Sequential Function Chart (SFC) and Structured Text (ST) routines. Like the Function Block Diagrams (FBD), online editing of SFC and ST routines is done at a routine level.
Finalize All Edits in a Program	The <i>Finalize All Edits in Program</i> option lets you make an online change to your logic <i>without</i> testing the change.

When you choose *Finalize All Edits in Program*:

- All edits in the program (pending and test), immediately download to the controller and begin execution.
- The original logic is permanently removed from the controller.
- Outputs that were in the original logic stay in their last state unless executed by the new logic (or other logic).
- If your edits include an SFC:
  - The SFC resets to the initial step.
  - Stored actions turn off.

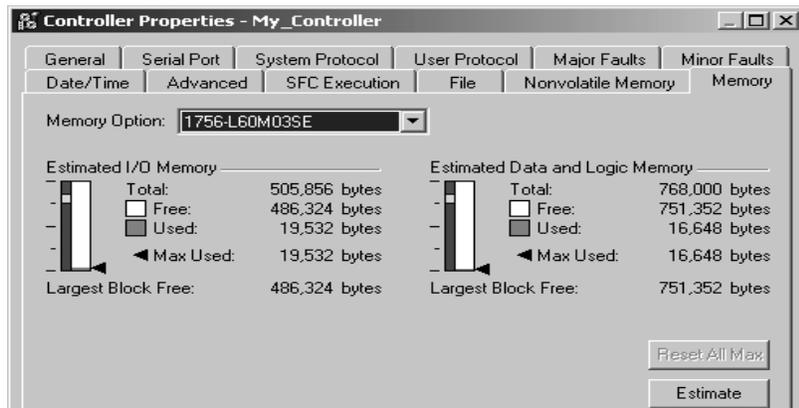
Estimate Memory Information Offline View Memory Information Online	<p>To estimate how much controller memory your project requires, use the <i>Memory</i> tab of the controller properties dialog box. For each of the memory areas of your controller, it lets you estimate number of bytes of:</p> <ul style="list-style-type: none"> <li>• free (unused) memory</li> <li>• used memory</li> <li>• largest free contiguous block of memory</li> </ul>
---	--

When online with a controller, the *Memory* tab shows the actual memory usage of the controller. The tab includes a *Max Used* entry for each type of memory. The *Max Used* values show the peak of memory usage as communications occur.

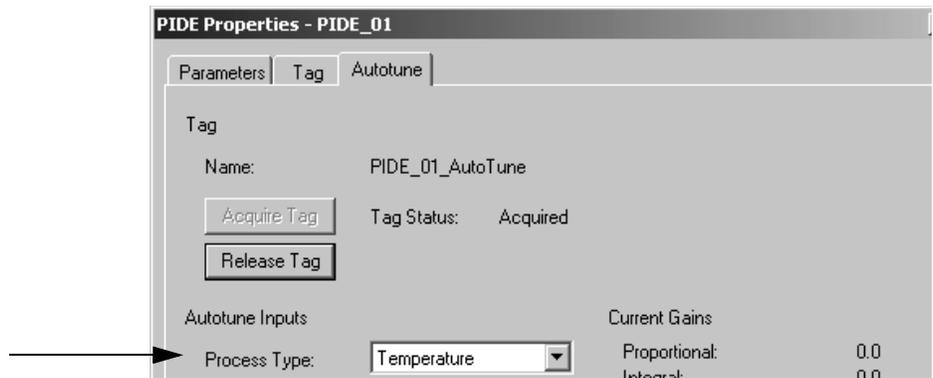
<b>Change:</b>	<b>Description:</b>
Out-of-Range Subscript No Longer Produces a Fault During Prescan	<p>During prescan, the controller automatically clears any faults due to an array subscript that is beyond the range of the array (out of range).</p> <p>In <i>previous</i> revisions, this produced a major fault.</p> <p style="text-align: right;">Lgx00040220</p>
AutoTune Now Uses a Non-Integrating Process Model for Temperature Processes	<p>When you autotune an Enhanced PID (PIDE) function block with the Process Type = Temperature, autotune now uses a non-integrating process model to estimate tuning constants. This gives better tuning constants for most application.</p>

In previous revisions, autotune used an integrating process model.

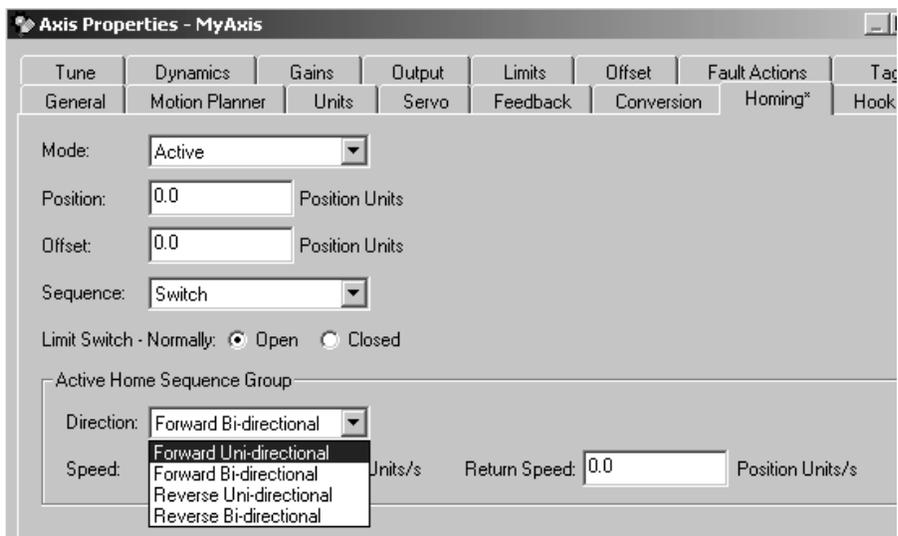
Corrected anomaly:	Description:
SERCOS Interface	<p>The SERCOS interface of the controller corrects the following anomalies that were in 1756-M08SE and 1756-M16SE modules, revision 12.x or earlier:</p> <ul style="list-style-type: none"> <li>• “Duplicate Node” error reporting operational when error is reported by SERCOS drives Verify that all drives on the SERCOS interface link support this functionality. The error can be viewed when on-line with RSLogix 5000 by opening the module’s Module Properties page, SERCOS interface Info Tab, and repeatedly selecting Refresh button to capture the error.</li> <li>• Corrected the anomaly with Real Time Axis Information support of “Accel. Feedback” attribute. The attribute was not recognized and caused the module to fail configuration.</li> </ul>
Uni-Directional Homing Failed to Complete	<p>A Motion Axis Home (MAH) instruction sometime failed to complete (IP bit remained on) under the following axis configuration:</p> <ul style="list-style-type: none"> <li>• Return Speed = 0</li> <li>• uni-directional homing (forward or reverse)</li> </ul>
