# **ControlLogix Standard Redundancy Firmware, Revision 16.57**

## **Redundancy Module Catalog Numbers**

1756-RM, 1757-SRM

These release notes describe enhancements, corrected anomalies, and known anomalies specific to redundancy system firmware, revision 16.57.

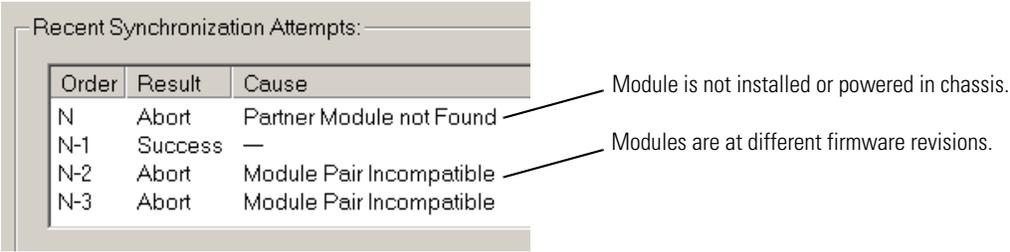
System Component	Enhancement
<b>1756-RM, 1756-RMXT</b>	<p>Synchronization failure reports enhanced by adding 'Partner Module not Found' cause.</p> <p>In previous revisions, if synchronization failed due to either of the causes described below, then failure was indicated by the same cause statement in the synchronization log of the RMCT. For both types of failures, 'Module Pair Incompatible' was indicated as the cause. Causes included:</p> <ul style="list-style-type: none"> <li>• partner modules at incompatible firmware revisions, or have mismatched configurations</li> <li>• a secondary module is not installed or powered</li> </ul> <p>With this firmware revision, the 1756-RM module is able to differentiate between partner incompatibilities and a missing secondary module. The RMCT indicates a missing secondary module by stating 'Partner Module not Found' in the Cause column of the Recent Synchronization Attempts log.</p>

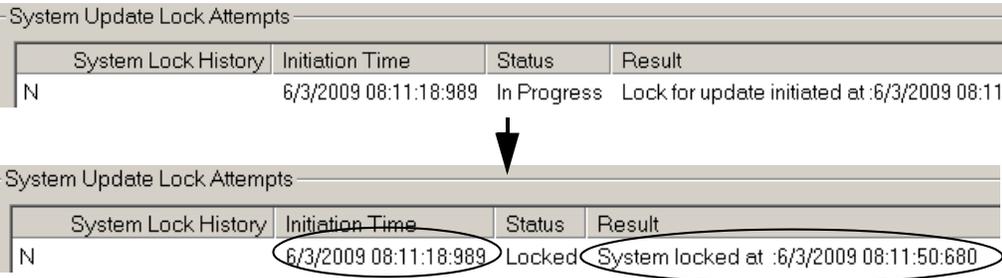
<p>The timestamps of Lock for Update and Initiate Locked Switchover commands are more precise.</p> <p>In previous firmware revisions, when the redundant system was locked for an update or a locked switchover was initiated, the 1756-RM module would indicate the same time for both the initiation and completion of those commands.</p> <p>With this revision, the initiation and completion of each of these commands is timestamped accordingly and the difference in time between initiation and completion can be observed.</p>

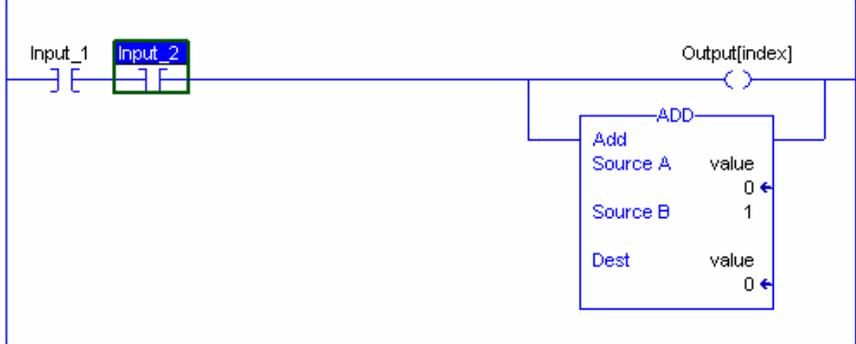
System Component	Description
<p><b>1756-L61, 1756-L62, 1756-L63, 1756-L64</b></p>	<p>Fault handlers can be defined at the controller and program scope levels. These fault handlers are typically used to handle major recoverable faults that can occur during runtime execution of an application due to programming errors. A typical example of this would be handling indirect addressing that has gone out of range; <code>MyTag[index]</code>, where <code>index</code> is larger than the size of the array.</p> <p>Faults can also be handled by the controller during pre-scan of the controller program on the transition to Run mode. Again, for example, the handling of indirect addressing that has gone out of range.</p> <p>There is an anomaly when these methods attempt to handle a fault.</p> <p>These are the possible ways the anomaly can manifest itself:</p> <ul style="list-style-type: none"> <li>• The controller will experience a major non-recoverable fault. I/O goes to their configured safe state, and the user application is cleared from memory. At this point, a Code 1 Type 60 or 61 major recoverable fault will be logged in the controller. This requires you to reupload the application.</li> <li>• Tag data corruption.</li> <li>• Online saving or uploading failures.</li> <li>• Anomalous program execution.</li> </ul> <p>For example, if a rung is being scanned false and there is an instruction that has false execution, the fault handler executes so the remainder of the rung will scan true. In the example below, the OTE instruction has an index out of range. After returning from the fault handler, the ADD instruction will execute, even though the rung input conditions are false.</p>

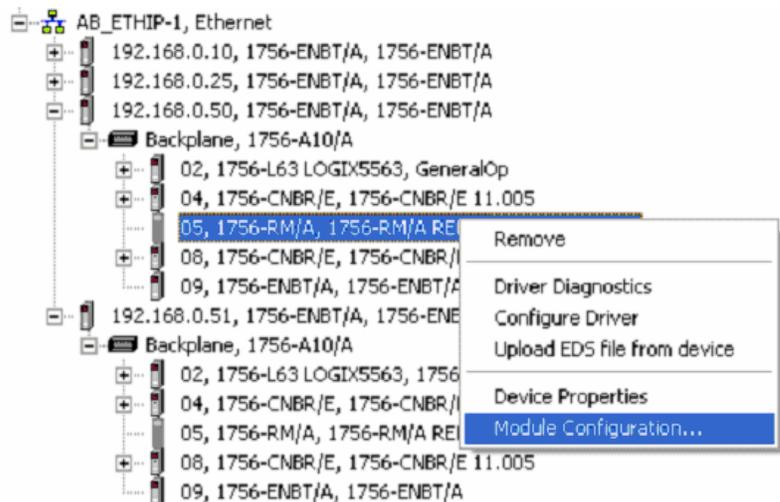
3. Right-click your redundancy module and choose Module Configuration.

The Module Configuration dialog box opens.

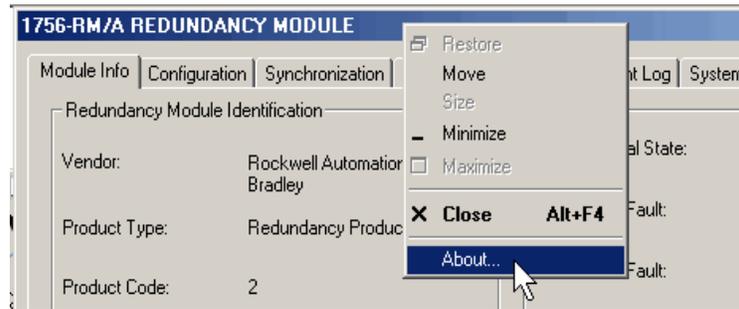
4. Right-click the title bar and choose About.

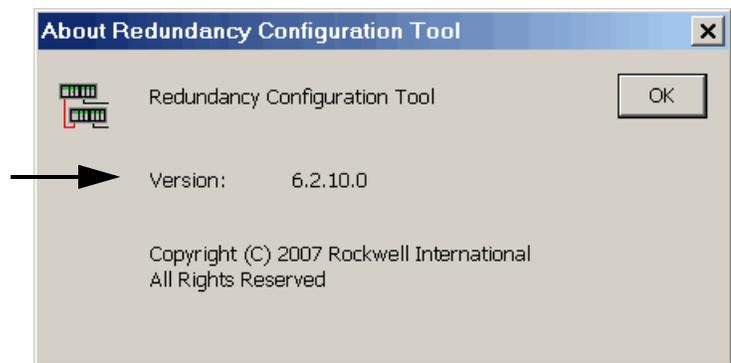
The About dialog box opens and indicates the RMCT version.

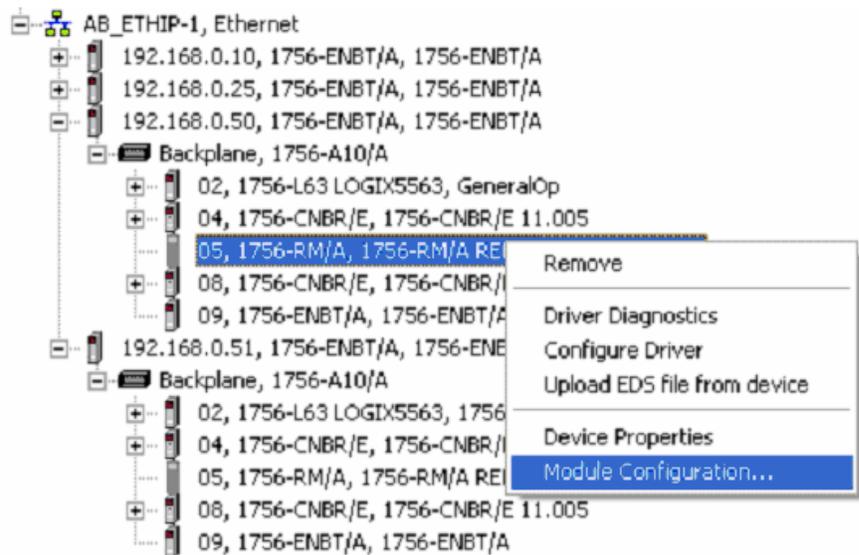
2. Open RSLinx Classic software and browse to the redundancy module.
3. Right-click the redundancy module and choose Module Configuration.

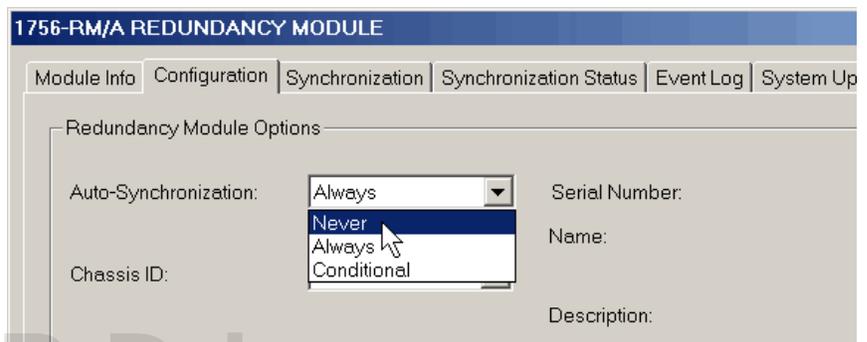
4. Click the Configuration tab.
5. From the Auto-Synchronization pull-down menu, choose Never.

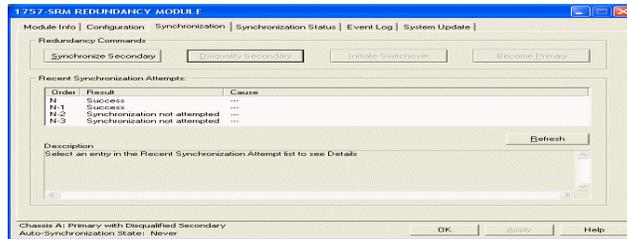
6. Click Apply, then click Yes.
7. Click the Synchronization tab.

8. Click Disqualify Secondary, then click Yes.

The secondary chassis is disqualified as indicated at the bottom-left of the RMCT and on the redundancy module's status display.

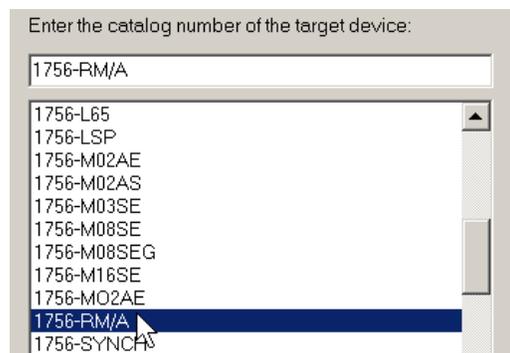
1. Launch ControlFlash software and click Next.
2. Select the redundancy module catalog number and click Next.

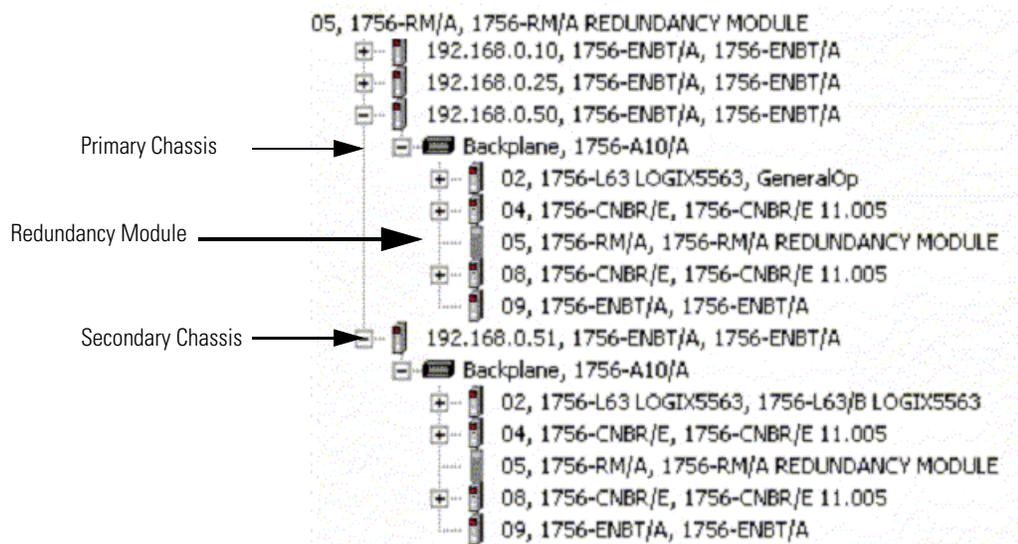
3. Browse to the redundancy module and select it.

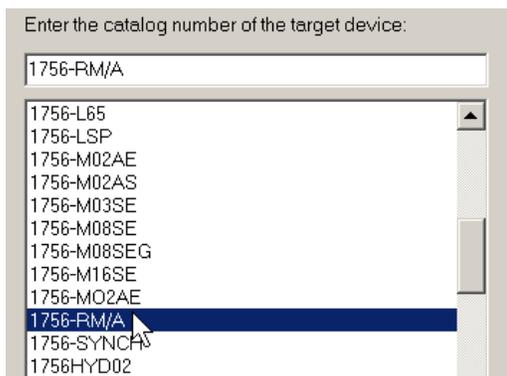
1. Launch ControlFlash software and click Next.
2. Select the redundancy module catalog number and click Next.

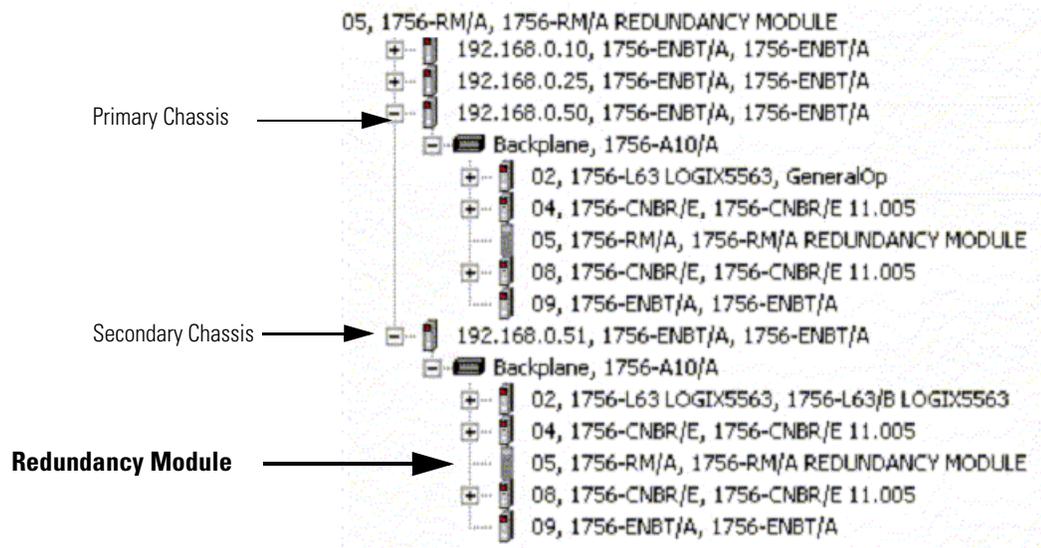
3. Browse to the redundancy module and select it.

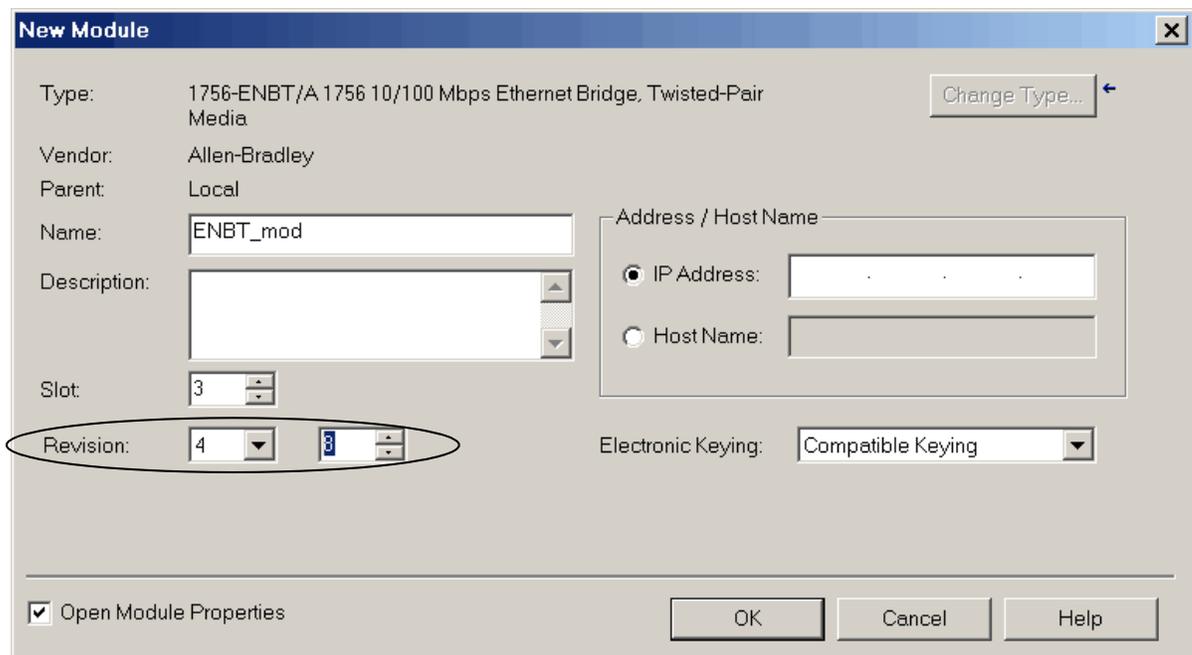
13. Access the Module Properties for each communication module in the chassis and specify the module firmware revision you are upgrading to.

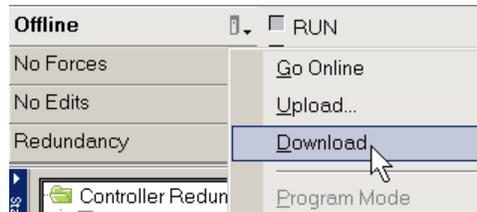
15. Download the project to the secondary controller.

The secondary controller is at the higher network address of the the two available for the redundant chassis.

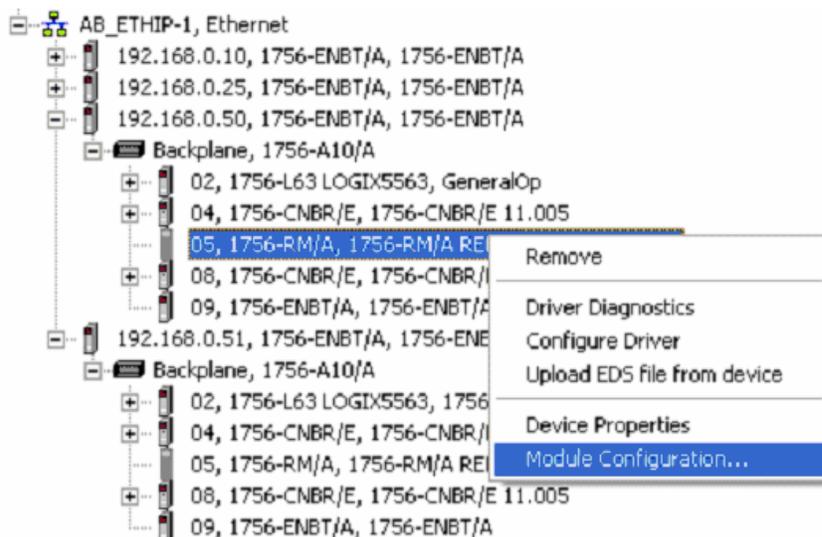
1. Open the RMCT for the 1756-RM module in the primary chassis.

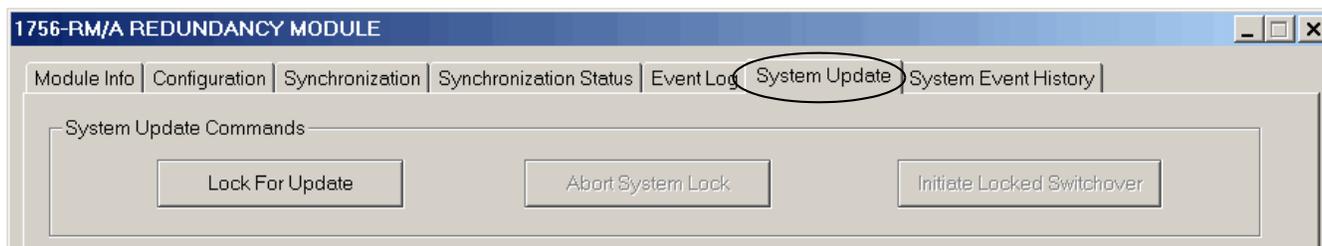
2. Click the System Update tab.

3. Click Lock for Update, then click Yes.
4. Wait for the system to lock.

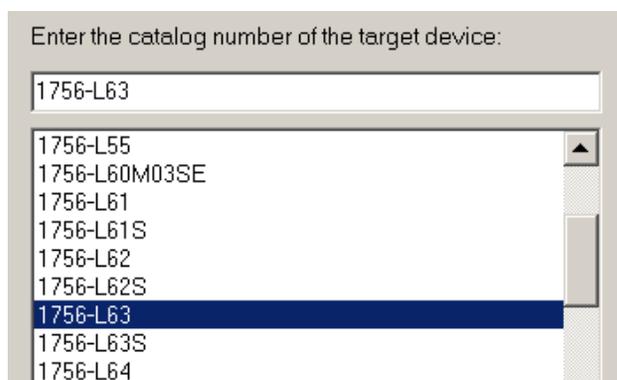
1. Launch ControlFlash software and click Next.
2. Select the module catalog number and click Next.

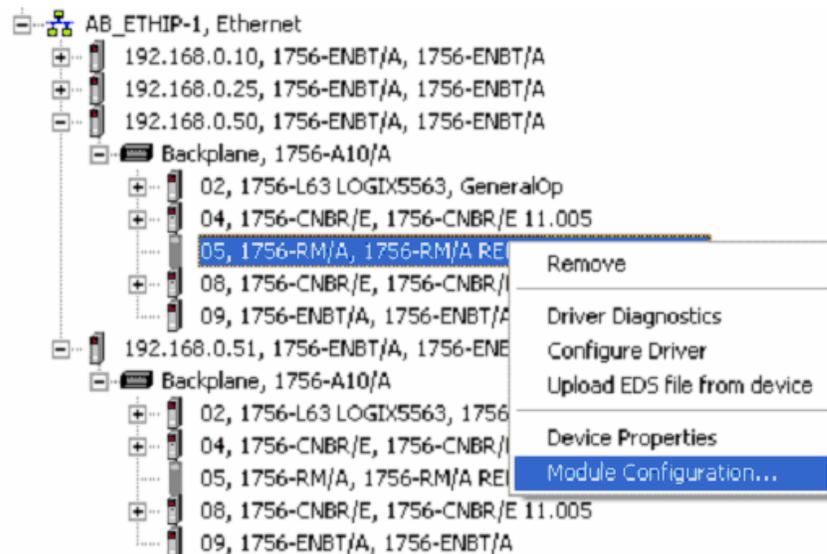
- Launch the RMCT for the 1756-RM module in the primary chassis.

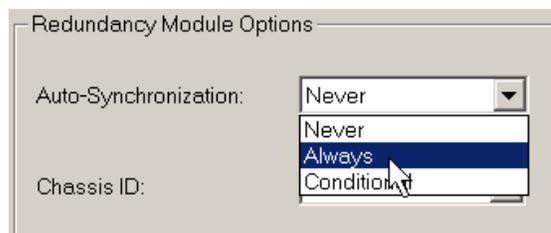
- Click the Configuration tab.
- From the Auto-Synchronization pull-down menu, choose the frequency that suits your application.

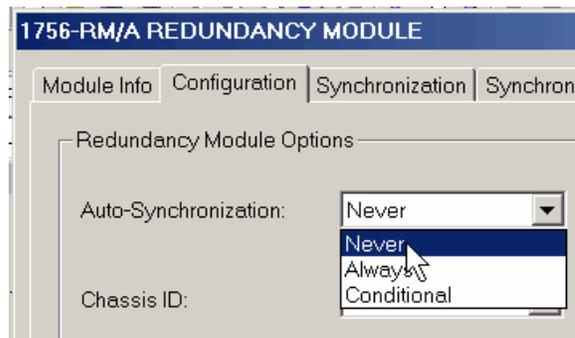
2. In the RMCT, click the Configuration tab and from the Auto-Synchronization pull-down menu, choose Never.

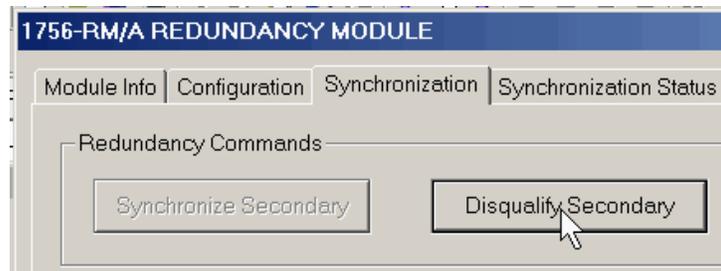
3. In the Synchronization tab, click Disqualify Secondary.

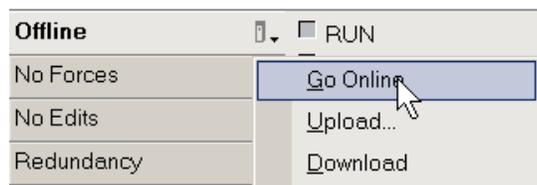
4. In RSLogix 5000 programming software, go online with the secondary controller.

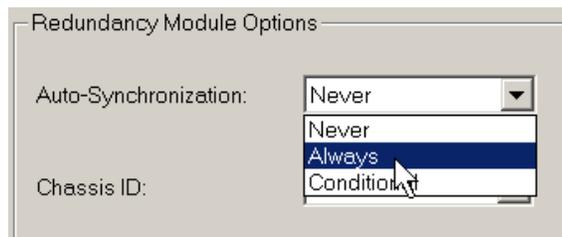
6. In the RMCT, set the Auto-Synchronization parameter according to your preference.
