ControlLogix Controllers, Revision 18

ControlLogix Controllers Catalog Numbers 1756-L73, 1756-L75

This publication describes anomalies (corrected and known), and restrictions for ControlLogix controllers, revision 18.

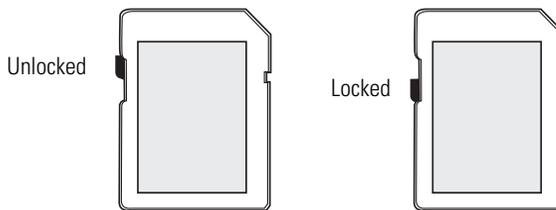
Figure 1 - SD Card - Unlocked and Locked

If your SD card is	Then
Unlocked	You can successfully update the firmware to the intended revision.
Locked and the Load Image option is set to On Power Up	You should unlock the SD card before beginning the update. If the card is locked when you attempt to update the firmware, the update fails and the controller reverts to the firmware revision already stored on the SD card.

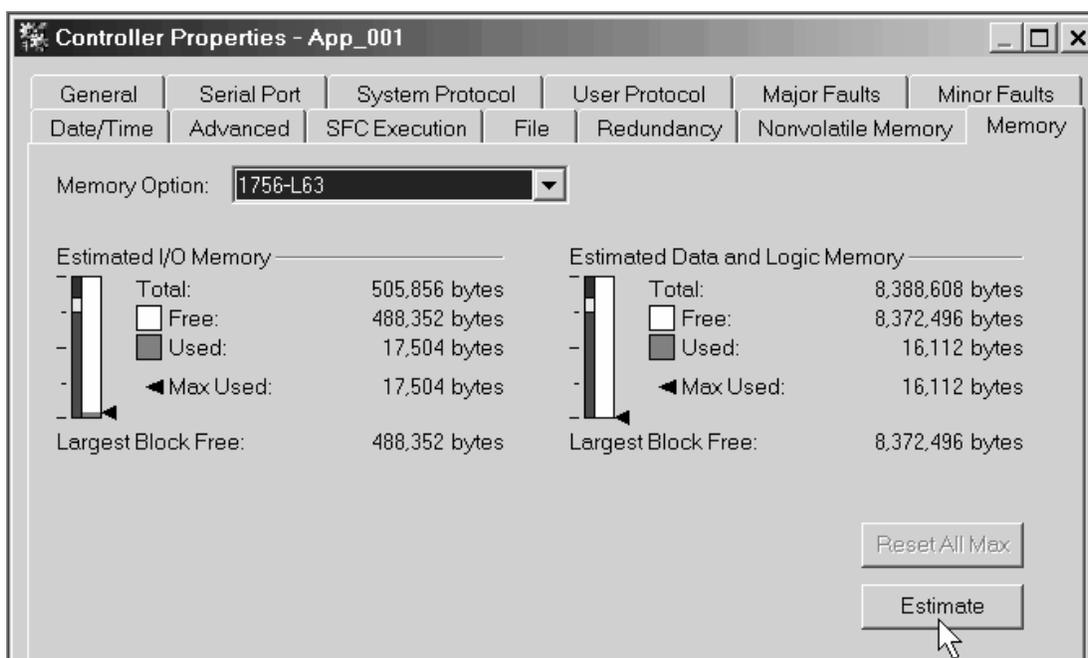
Use the Estimate Tool

To estimate the amount of memory required by your application, convert the project to the controller revision desired and use the Estimate tool available in the Memory tab of the Controller Properties.

When used with a 1756-L7x controller, the RSLogix 5000 programming software Estimate Memory tool does not provide exact memory requirement values.
