1769 CompactLogix Controllers, Revision 18

Controller Catalog Numbers 1769-L31, 1769-L32C, 1769-L32E, 1769-L35CR, 1769-L35E

This publication describes enhancements, anomalies (known and corrected), and restrictions for the 1769 CompactLogix controllers, revision 18.

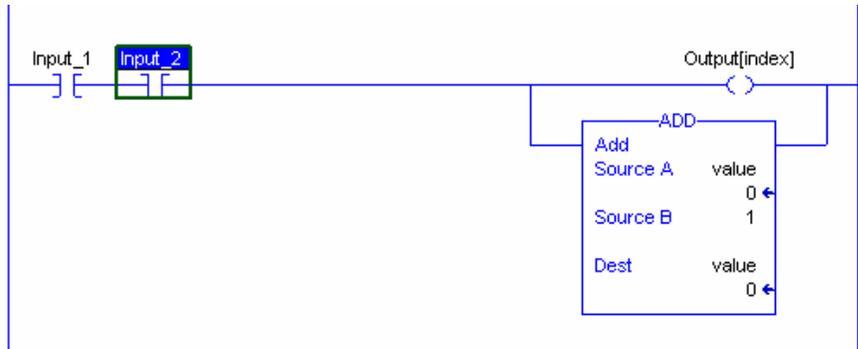
Cat. No.	Description
1769-L31, 1769-L32C, 1769-L32E, 1769-L35CR, 1769-L35E	<p>CORRECTED: Fault handlers can be defined at the controller and program scope levels. These fault handlers are typically used to handle Major Recoverable Faults that can occur during runtime execution of an application due to programming errors. A typical example of this would be handling indirect addressing that has gone out of range; MyTag[index], where index is larger than the size of the array.</p> <p>Faults can also be handled by the controller during pre-scan of the controller program on the transition to Run mode. Again, for example, the handling of indirect addressing that has gone out of range.</p> <p>There is an anomaly when these methods attempt to handle a fault.</p> <p>These are the possible ways the anomaly can manifest itself:</p> <ul style="list-style-type: none"> • The controller will experience a Major Nonrecoverable Fault (MNRF). I/O goes to their configured safe state, and the user application is cleared from memory. At this point, a Code 1 Type 60 or 61 Major Recoverable Fault will be logged in the controller. This requires you to re-download the application. • Tag data corruption. • Online saving or uploading failures. • Anomalous program execution. <p>For example, if a rung is being scanned false and there is an instruction that has false execution, the fault handler executes so the remainder of the rung will scan true. In the example below, the OTE instruction has an index out of range. After returning from the fault handler, the ADD instruction will execute, even though the rung input conditions are false.</p>

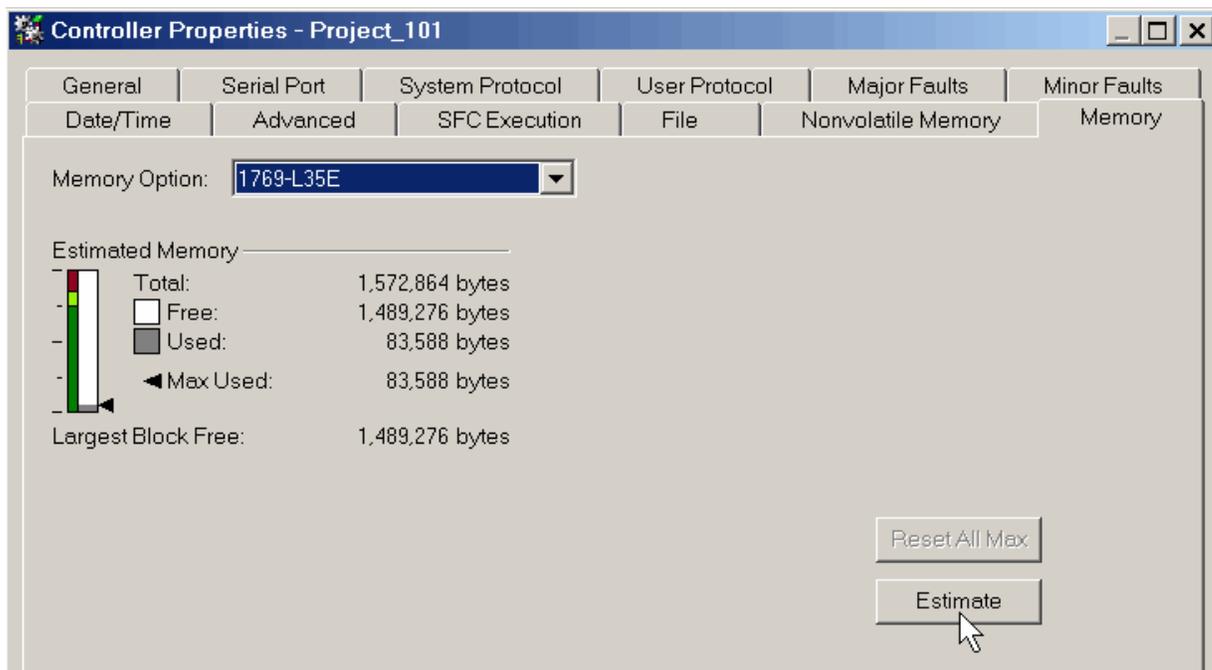
Use the Estimate Tool

To estimate the amount of memory required by your application, convert the project to the controller revision desired and use the Estimate tool available in the Memory tab of the Controller Properties.
