# 1769 CompactLogix Packaged Controllers, Revision 19

Catalog Numbers 1769-L31, 1769-L32C, 1769-L32E, 1769-L35CR, 1769-L35E

This publication describes enhancements, anomalies (known and corrected), and restrictions for 1769-L3x CompactLogix™ packaged controllers, revision 19.13.

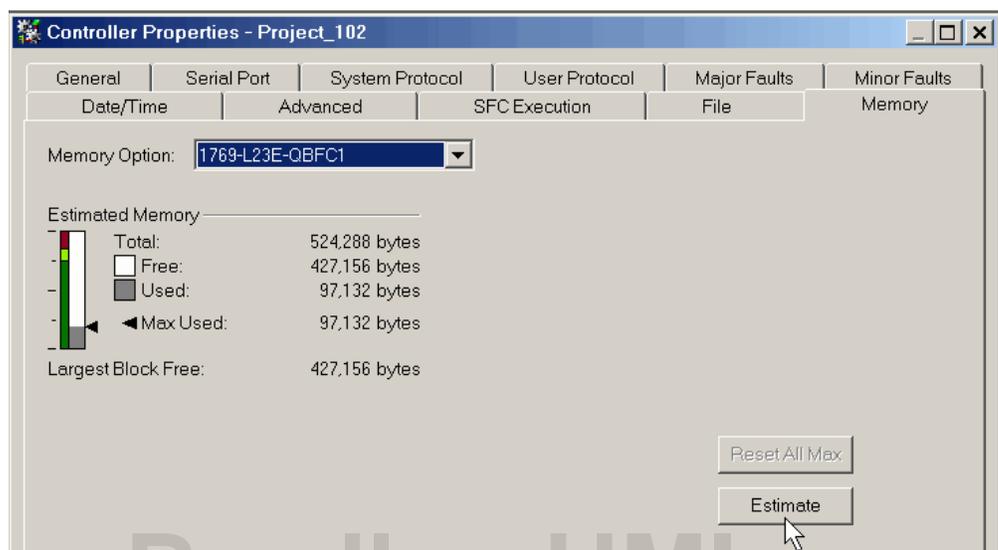
### Use the Estimate Tool

To estimate the amount of memory required by your application, convert the project to the controller revision desired and use the Estimate tool available in the Memory tab of the Controller Properties.
