Classic PLC-5 Programmable Controller Firmware Upgrade (Catalog Numbers 1785-LT1, -LT2, -LT3, -LT4)

Using These Instructions

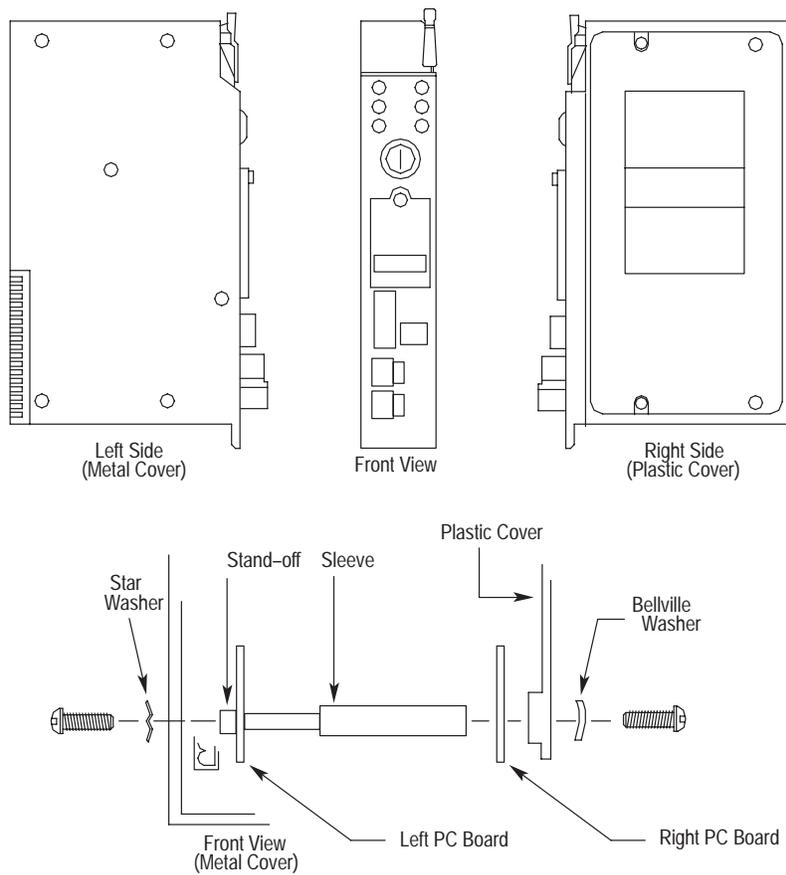
20665-M

- 1 Before you disassemble the processor, check to ensure that you have a backup copy of the customer program on hard disk or tape.
- 2 Being careful not to lose the washers, remove the four screws from the plastic cover and note the orientation of the stand-offs and sleeves.

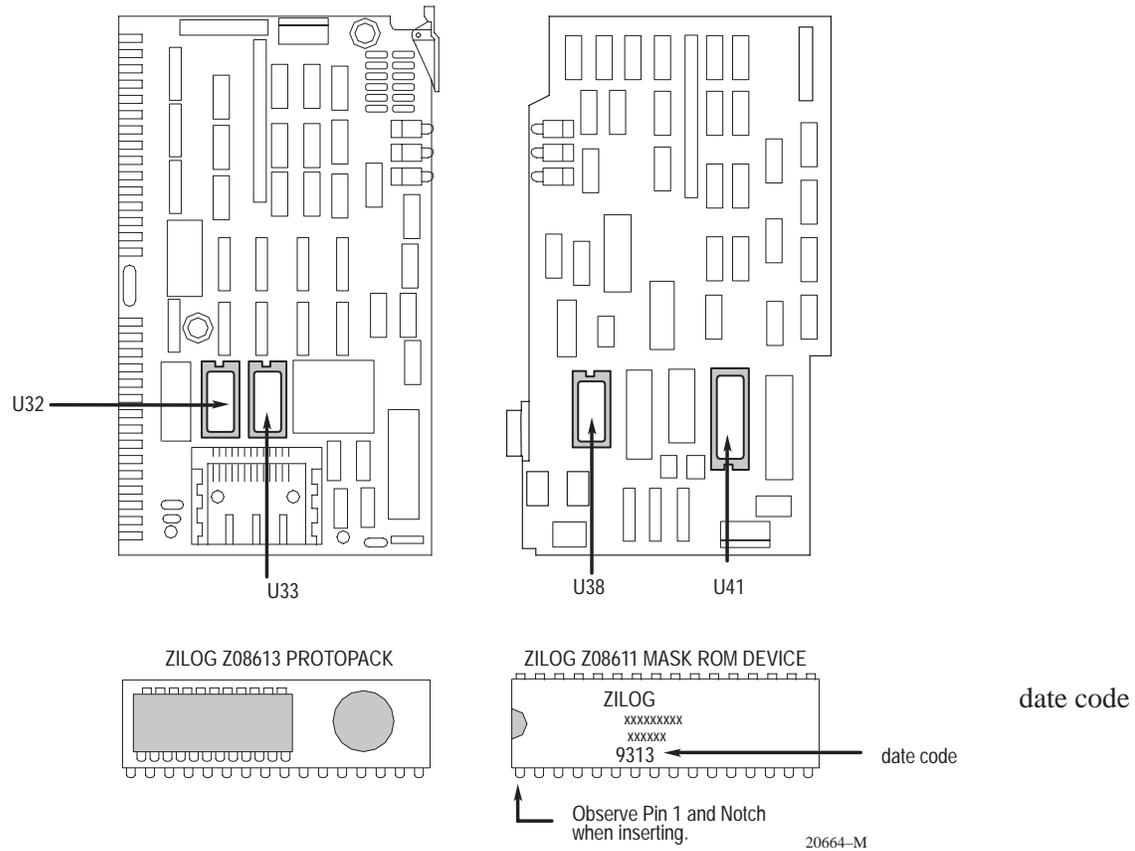
- 3 Remove the screw from under the plastic cover.
- 4 Being careful not to damage the interboard connector pins, separate the two printed circuit boards.
- 5 Replace the firmware PROMs in locations U32, U33, and U38. Observe the pin 1 locator and make certain that no pins are bent under.

- 6 If your processor has a protopack device in location U41, replace it with the masked ROM device included with this update kit. If U41 is already a masked ROM, and the date code on that part is 9242 or earlier, replace it. If U41 is a masked ROM with a date code of 9243 or later, skip this step.
