SoftLogix 5 Controller Release Note

version 2.0 (Cat. No. 1789-SL5,1789-SL51,1789-SL52)

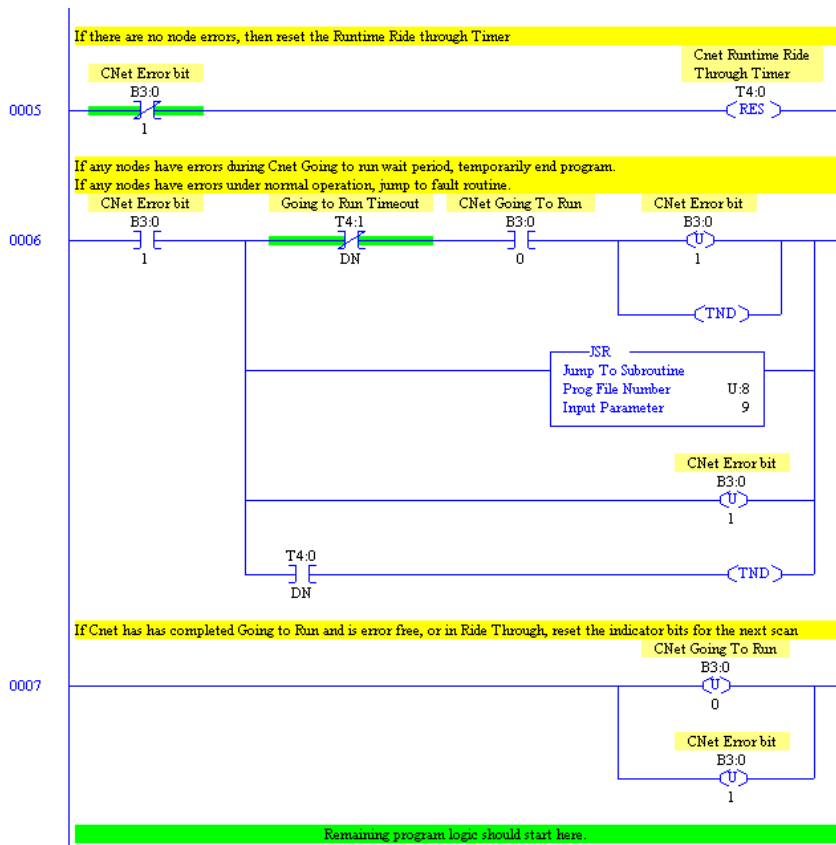
0005	If there are no errors, reset the Cnet Runtime Ride Through Timer.
0006	If ControlNet errors have occurred: <ol style="list-style-type: none"> If the ControlNet Timer is not done and the ControlNet Going To Run bit is set, temporarily end the program. If an error has occurred during the program scan, set a user-defined major fault and jump to the fault routine. If the Ride Through Timer is Done, temporarily end the program.
0007	Reset the flags that invoke the ControlNet error checking.
