SoftLogix 5 Controller Release Note

version 2.0

(Cat. No. 1789-SL5, 1789-SL51, 1789-SL52)

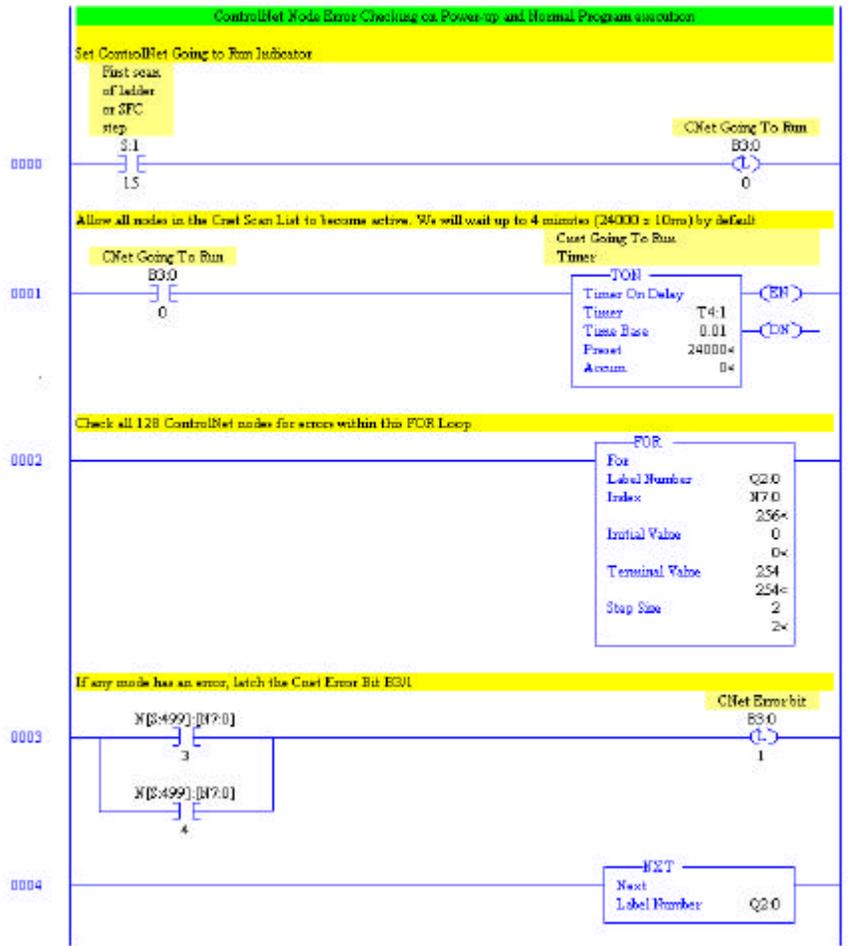
This rung: Performs this function:

0000	Latch the CNet Going to Run bit as flag that indicates this is the first program scan.
0001	If this is the first program scan, set a timer that waits up to 4 minutes for all scheduled ControlNet nodes to come online without any errors. The Preset of 4 minutes can be changed for your system.
0002	Start a FOR/NXT loop to step through the ControlNet Status file and look for any connection errors for the 128 possible connections. This check occurs each scan.
0003	S:499 identifies the Integer file that is configured as the ControlNet Status file. The two values that are being checked indicate whether the connection is faulted or the connection is extinct. If one of these errors occurs, set the CNet Error bit.
0004	End the FOR/NXT loop.

WARNING: Use the logic in the ladder program when using ControlNet I/O. Failure to use this logic could cause unpredictable machine operation with possible damage to equipment and/or injury to personnel.

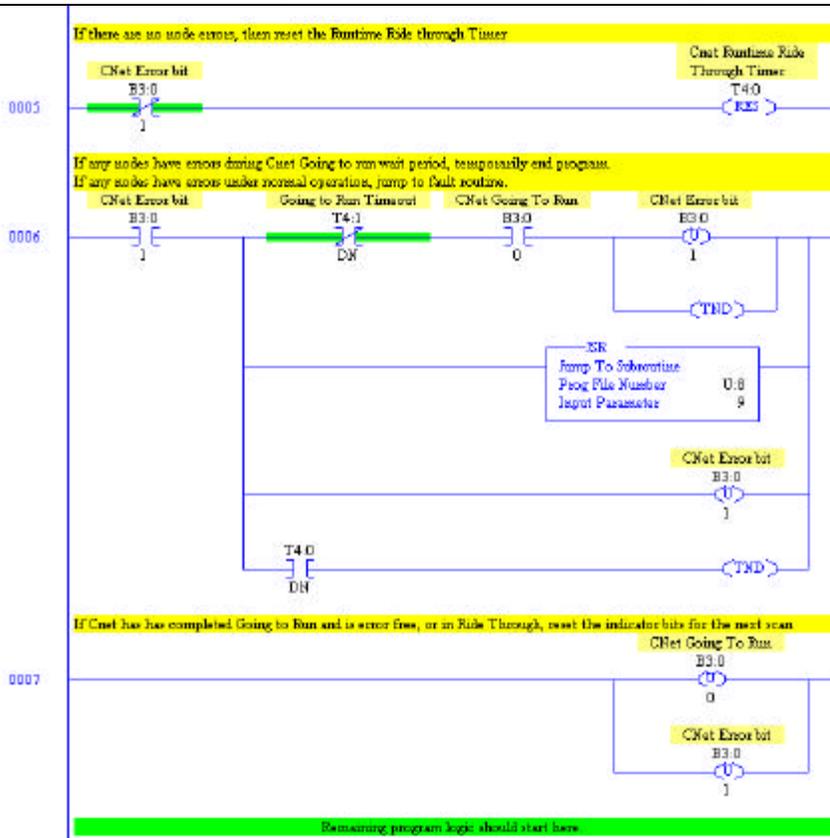
This rung: Performs this function

- 0005 If there are no errors, reset the Cnet Runtime Ride Through Timer.
- 0006 If ControlNet errors have occurred:
 1. If the ControlNet Timer is not done and the ControlNet Going To Run bit is set, temporarily end the program.
 2. If an error has occurred during the program scan, set a user-defined major fault and jump to the fault routine.
 3. If the Ride Through Timer is Done, temporarily end the program.
- 0007 Reset the flags that invoke the ControlNet error checking.

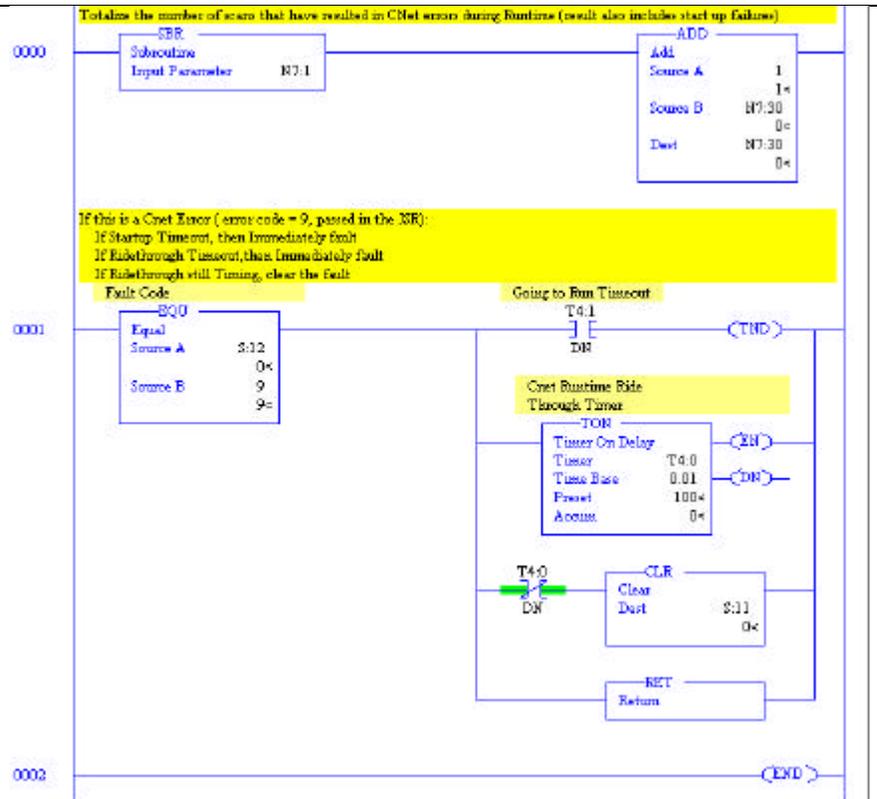
This is the fault routine that processes the ControlNet errors.

This rung: Performs this function

1. If the Going to Run Timer has expired, go to Faulted mode.
2. Start or update the RideThrough Timer.
3. If the Ride Through Timer is timing, clear the fault.
4. Otherwise the Ride Through Timer has expired, go to Faulted mode.

0002 End the fault routine.
