PowerFlex 700H Drive Firmware Revision 6.001

These release notes correspond to major revision 6, minor revision 1 of firmware for PowerFlex 700H drives.

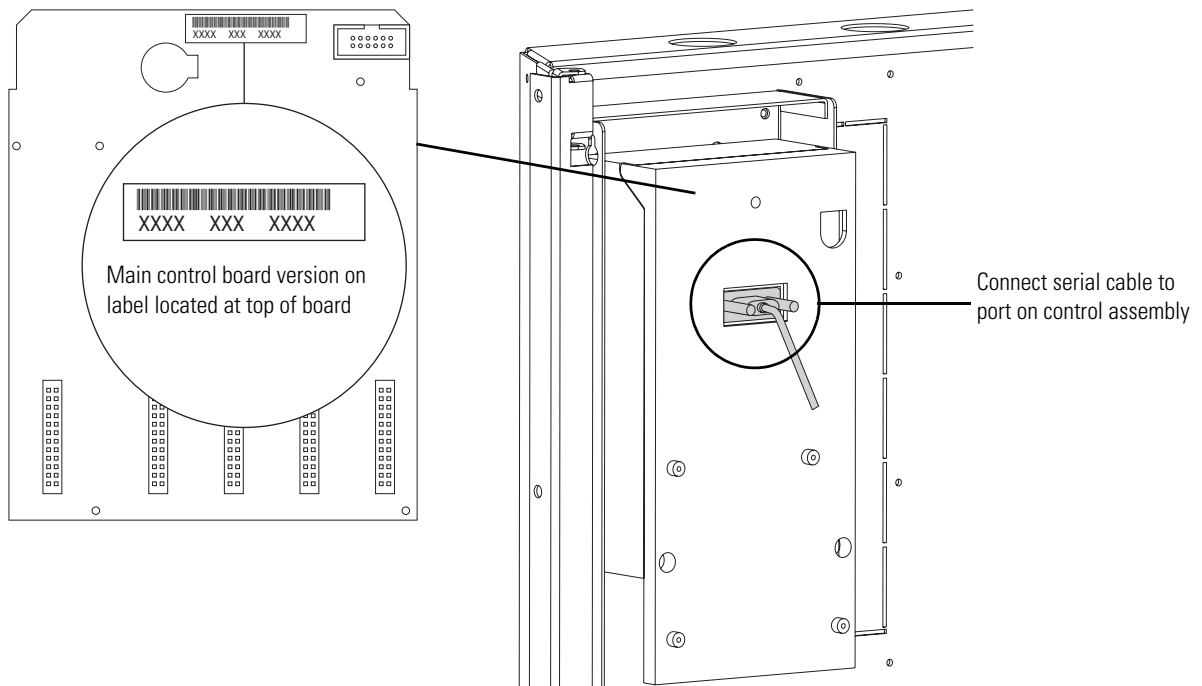
Figure 1 - Serial Cable Connection to Control Assembly Port

1. Connect the serial cable from your computer to the port on the front of the 700H control assembly as shown below.

See [Figure 1 on page 3](#) for location of version number on the main control board.
